**SML**  
**Sedimentation Monitoring Plan**  
**Project 2210-197**

Input on 2021 Draft Report  
SML Citizen Action Group  
September 30, 2023, updated 10/25/23

# Gills Creek Monitoring Site Citizen Input

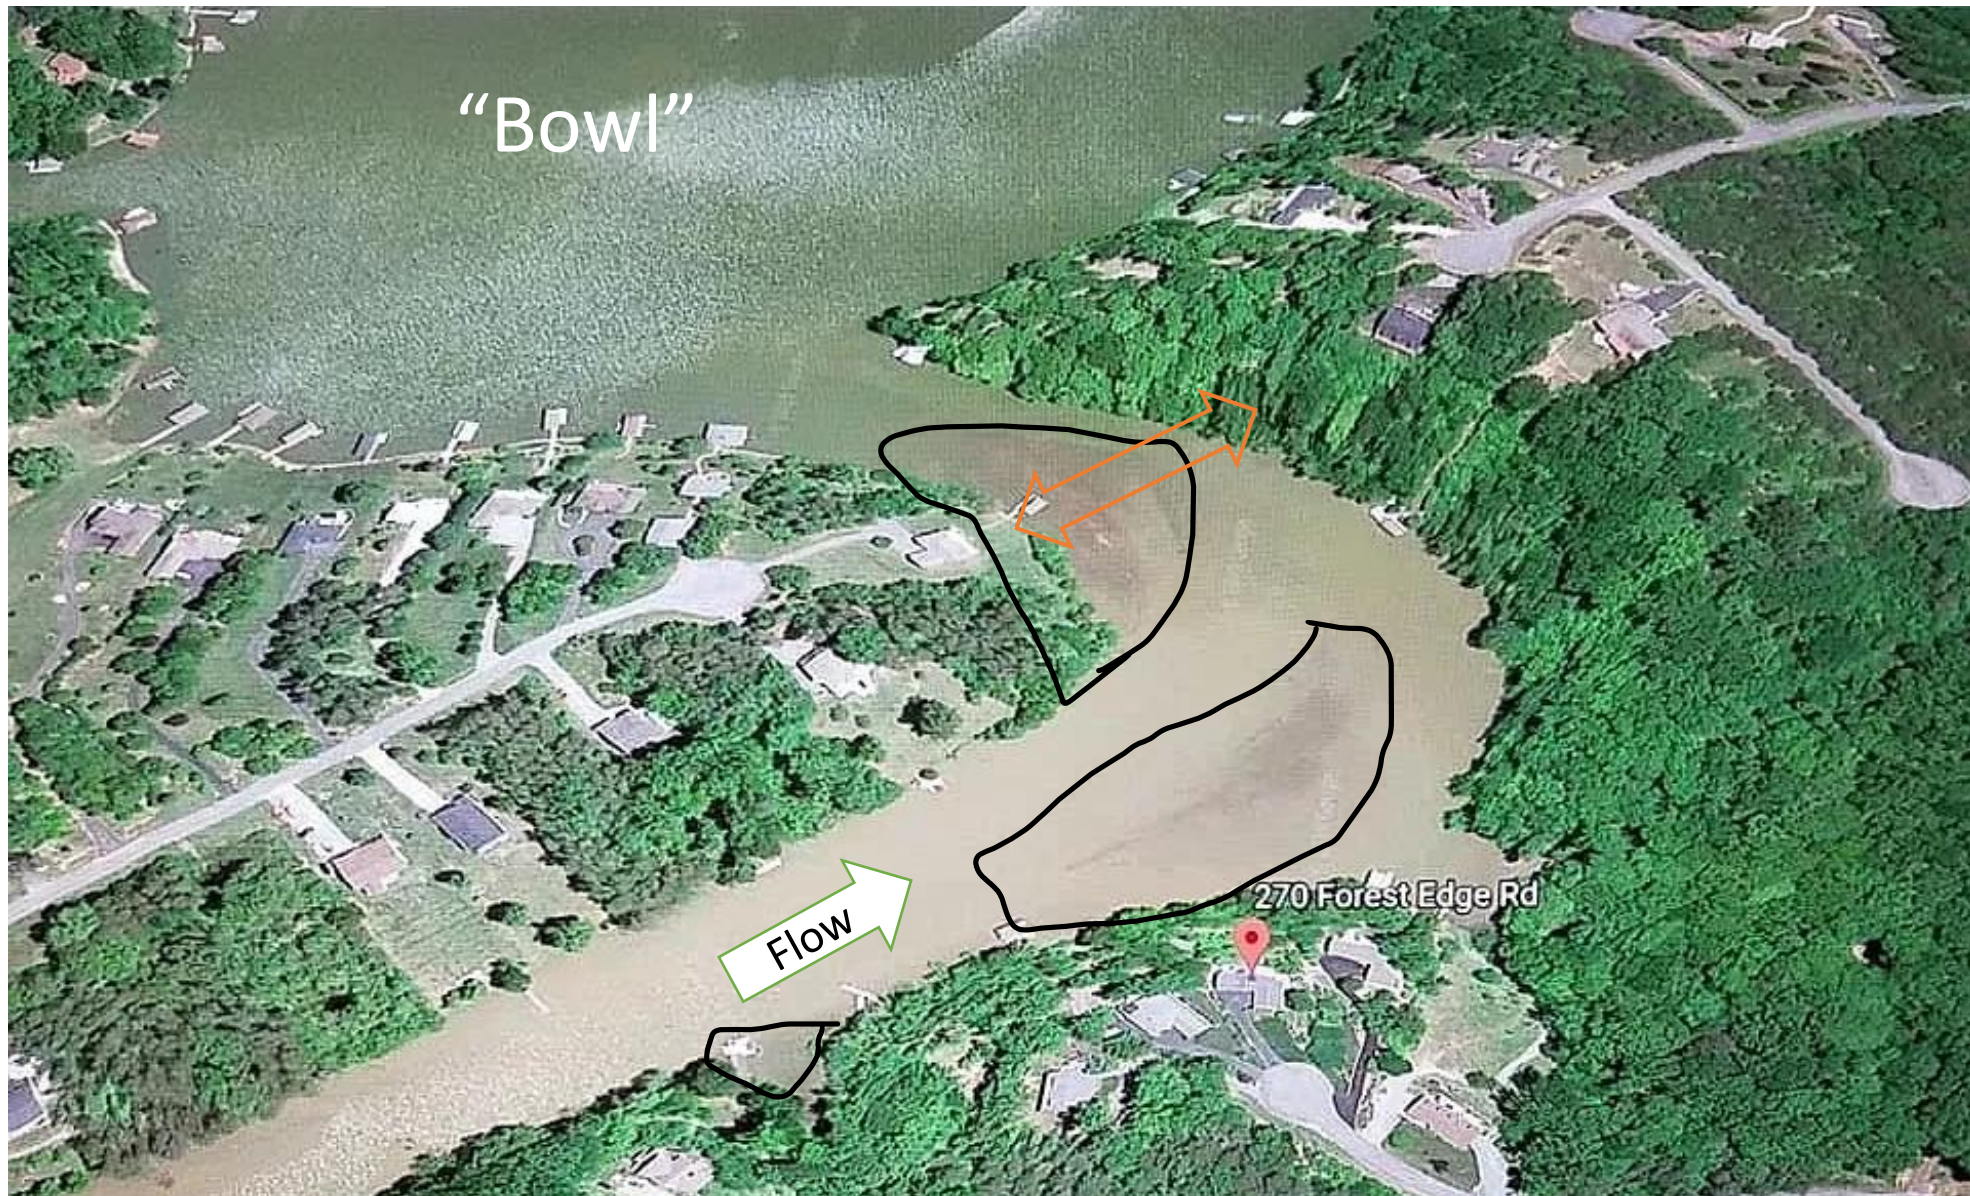
2017 Upper Gills Creek Identified Area with Sediment accumulating, severely obscuring the opening downstream

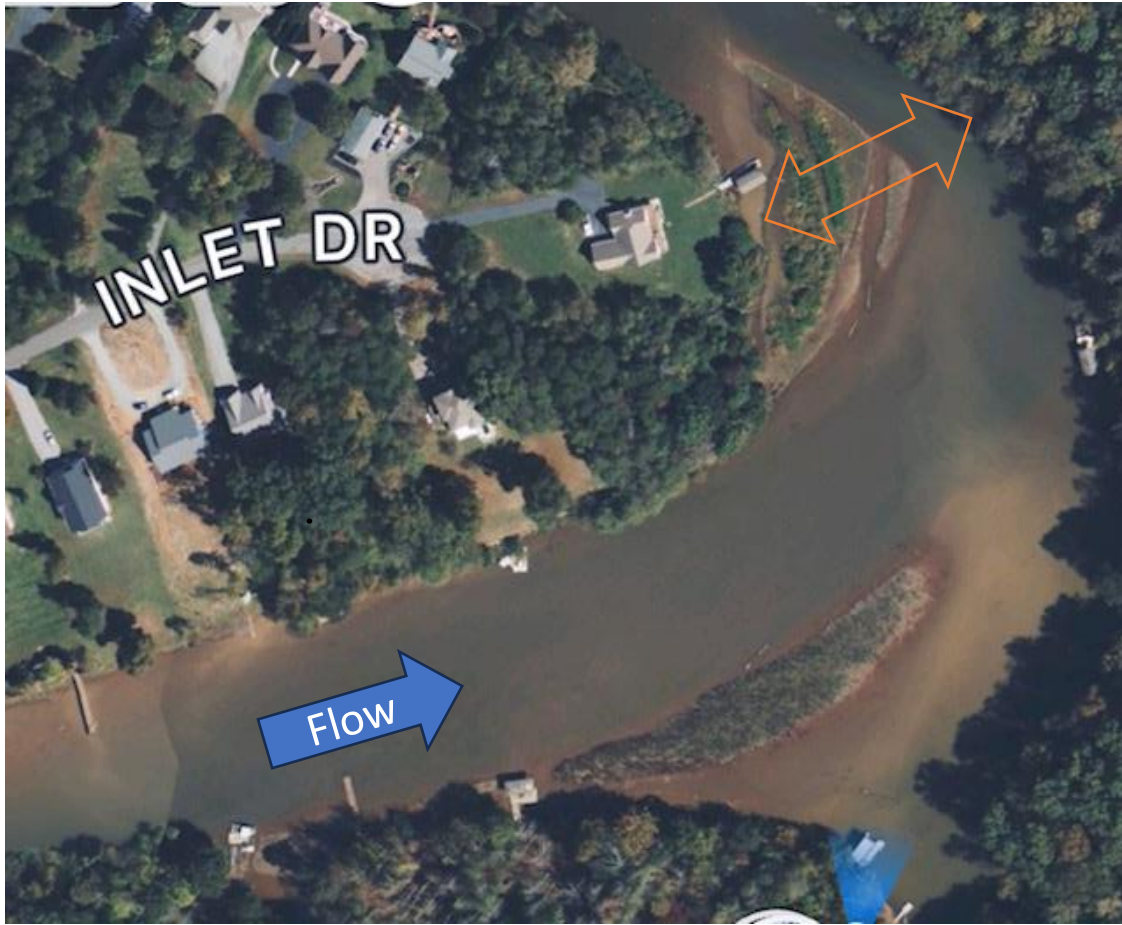
**Continued depositing of silt, until vegetation is growing thicker and trapping even more sediment, almost closing the mouth of the channel and rendering many docks unusable**

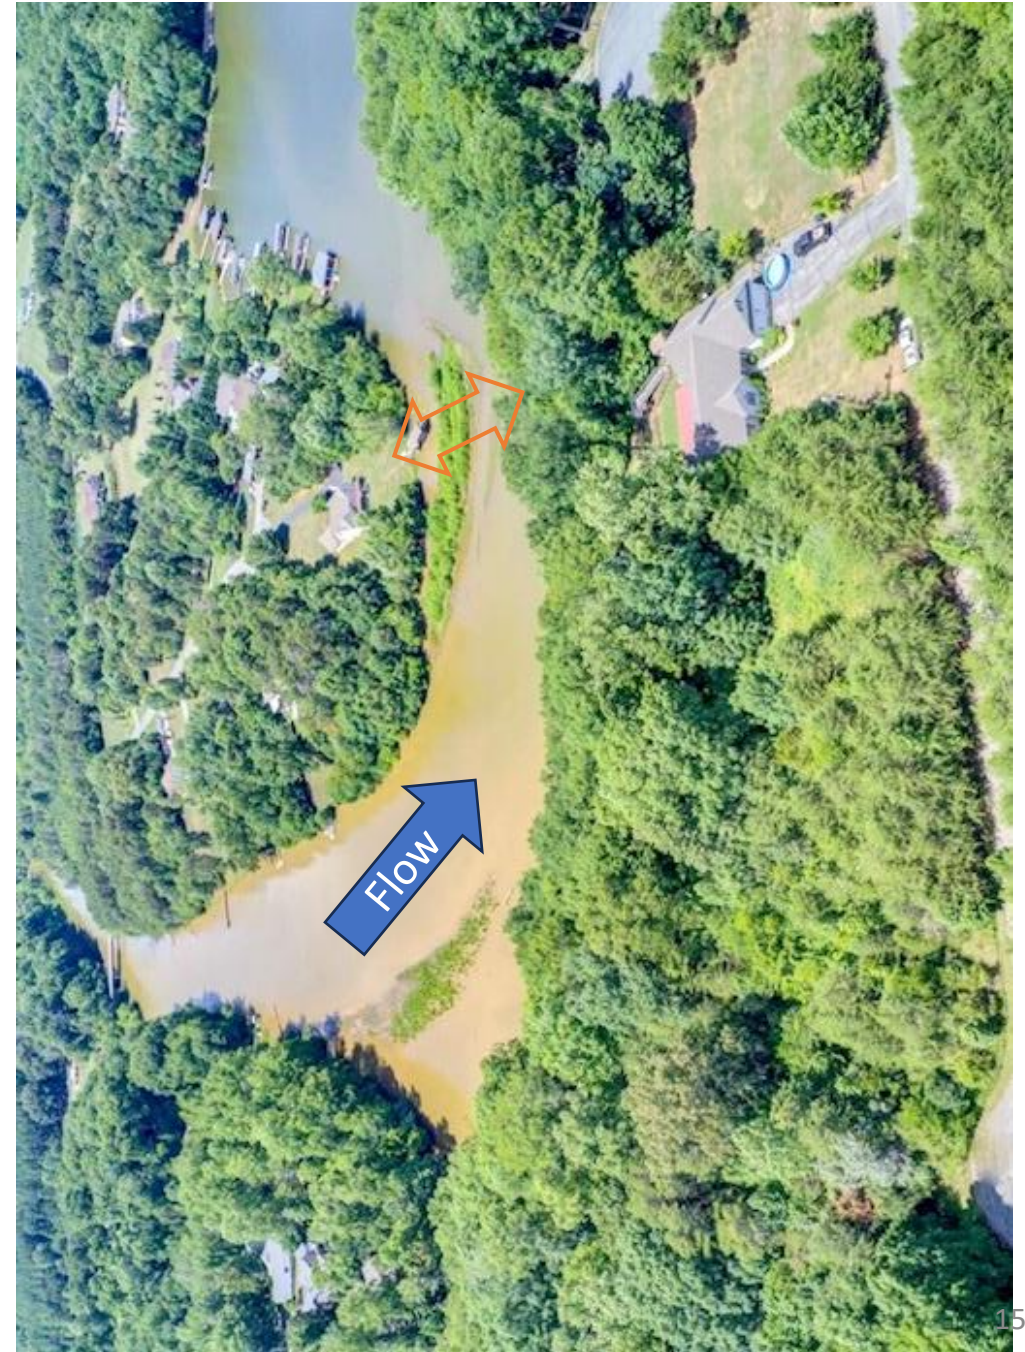
A winter 2021 photo, when sediment continued to grow. The direction of the creek flow to the dam is marked. The two large sediment islands are marked.

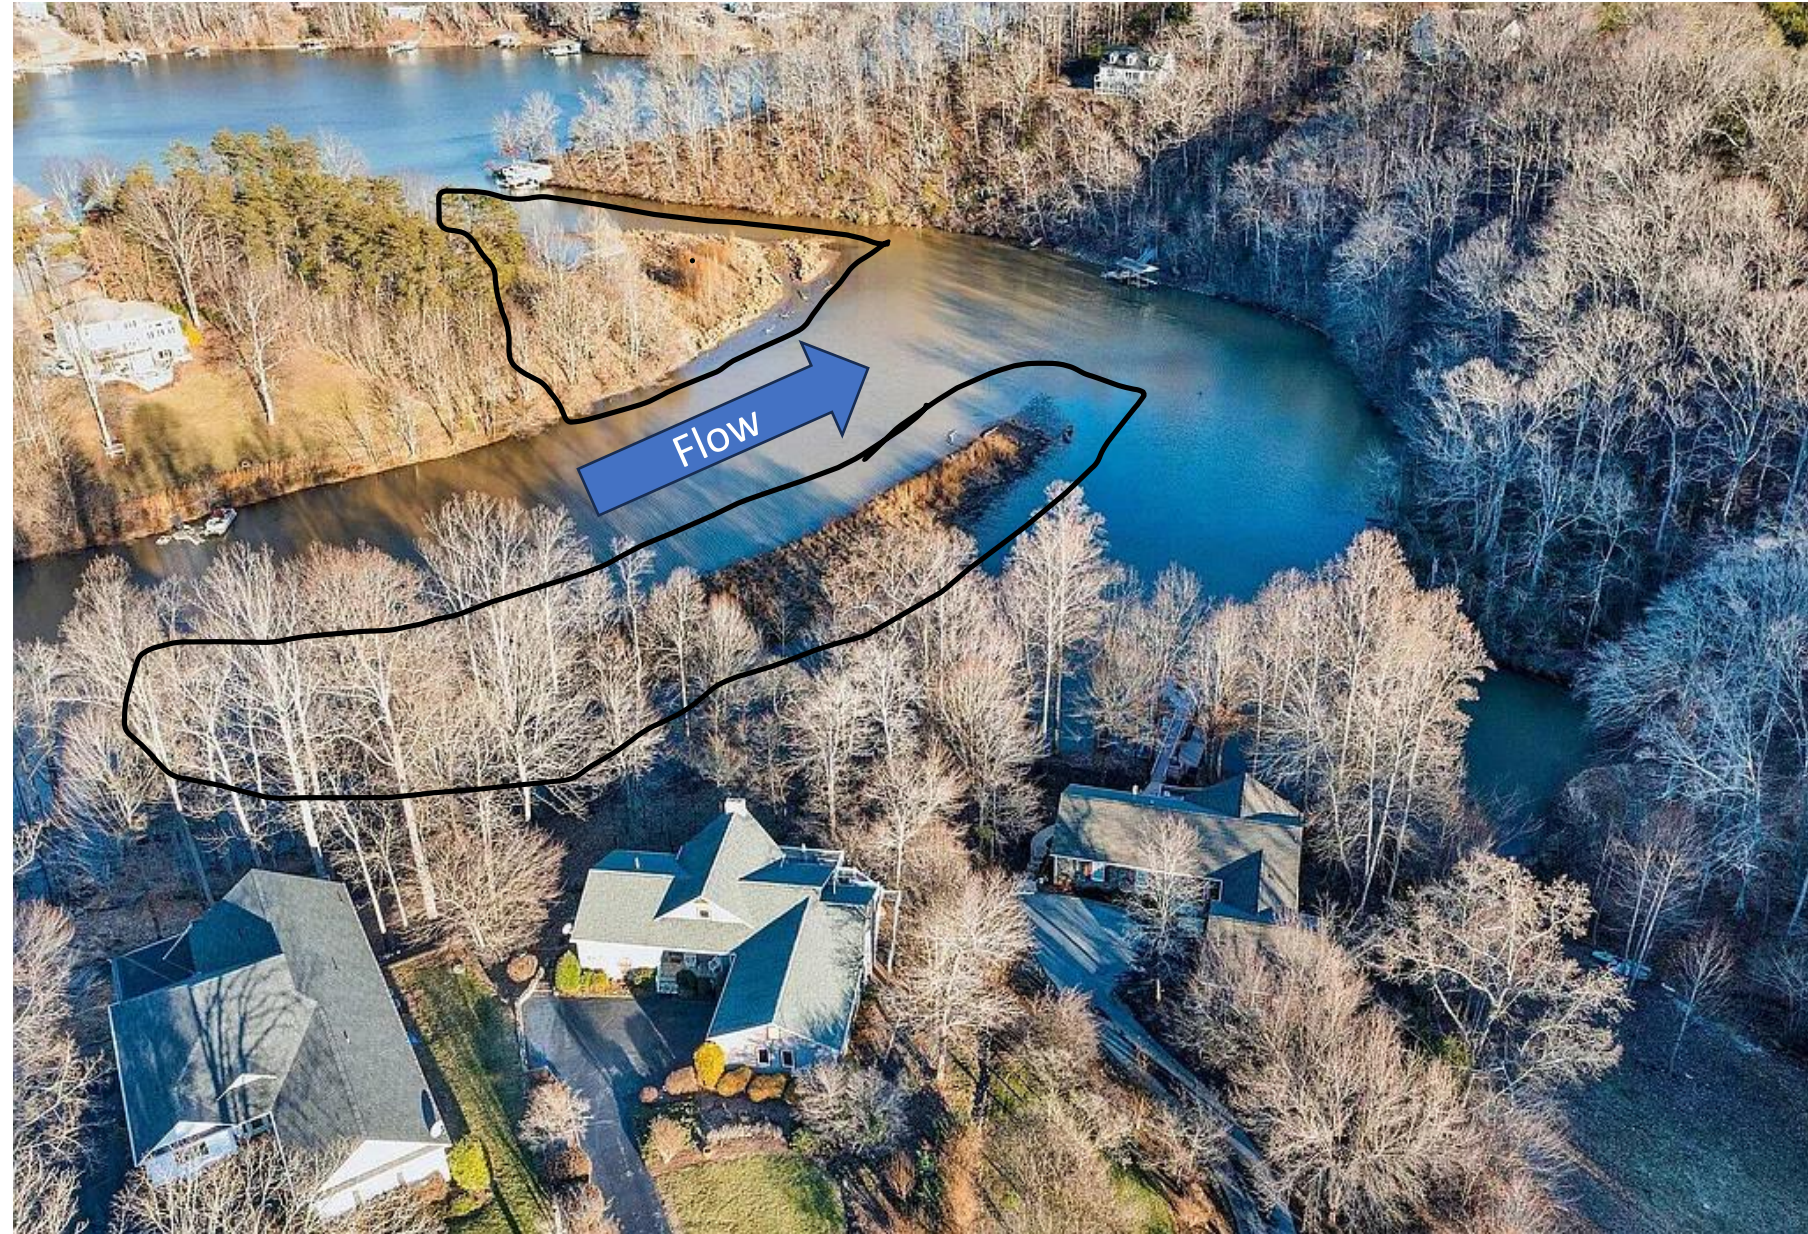
The severely narrowed Gills Creek Channel looking upriver from the “bowl” where sediment deposits have obstructed a dock (where the X is) and created navigational hazards, more silt and sediment deposition, and debris fields. The docks below the X, outside of the monitoring site, are also experiencing increased siltation and debris.

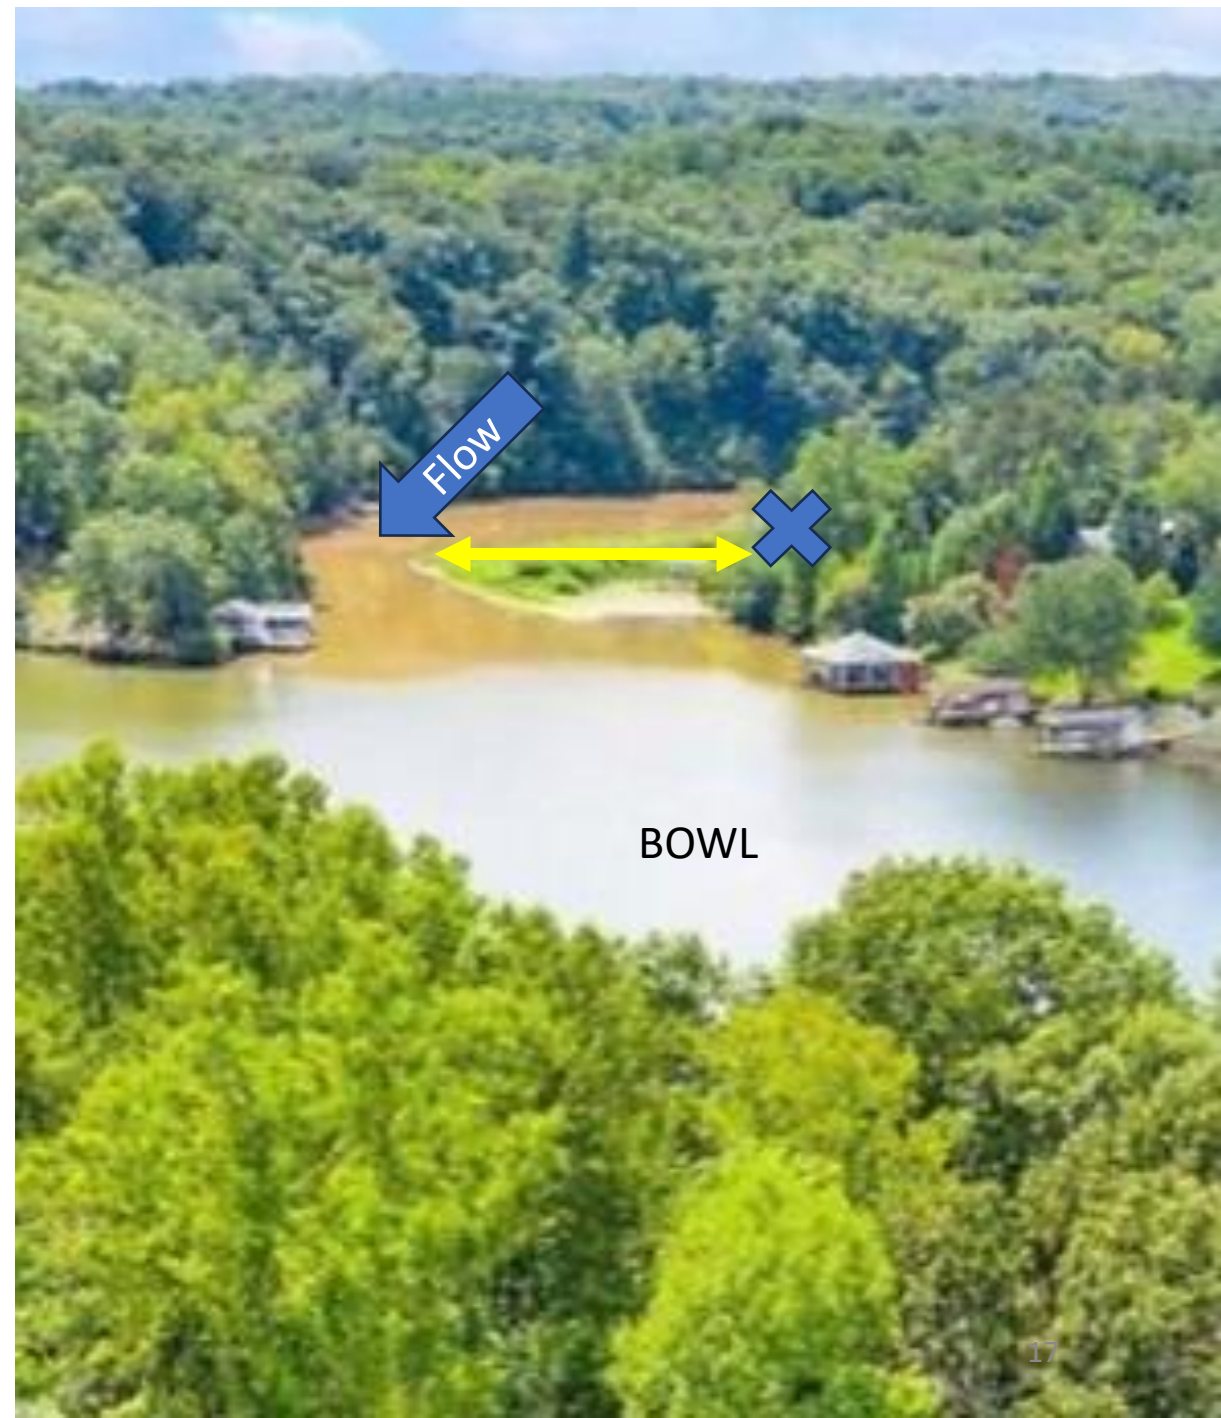
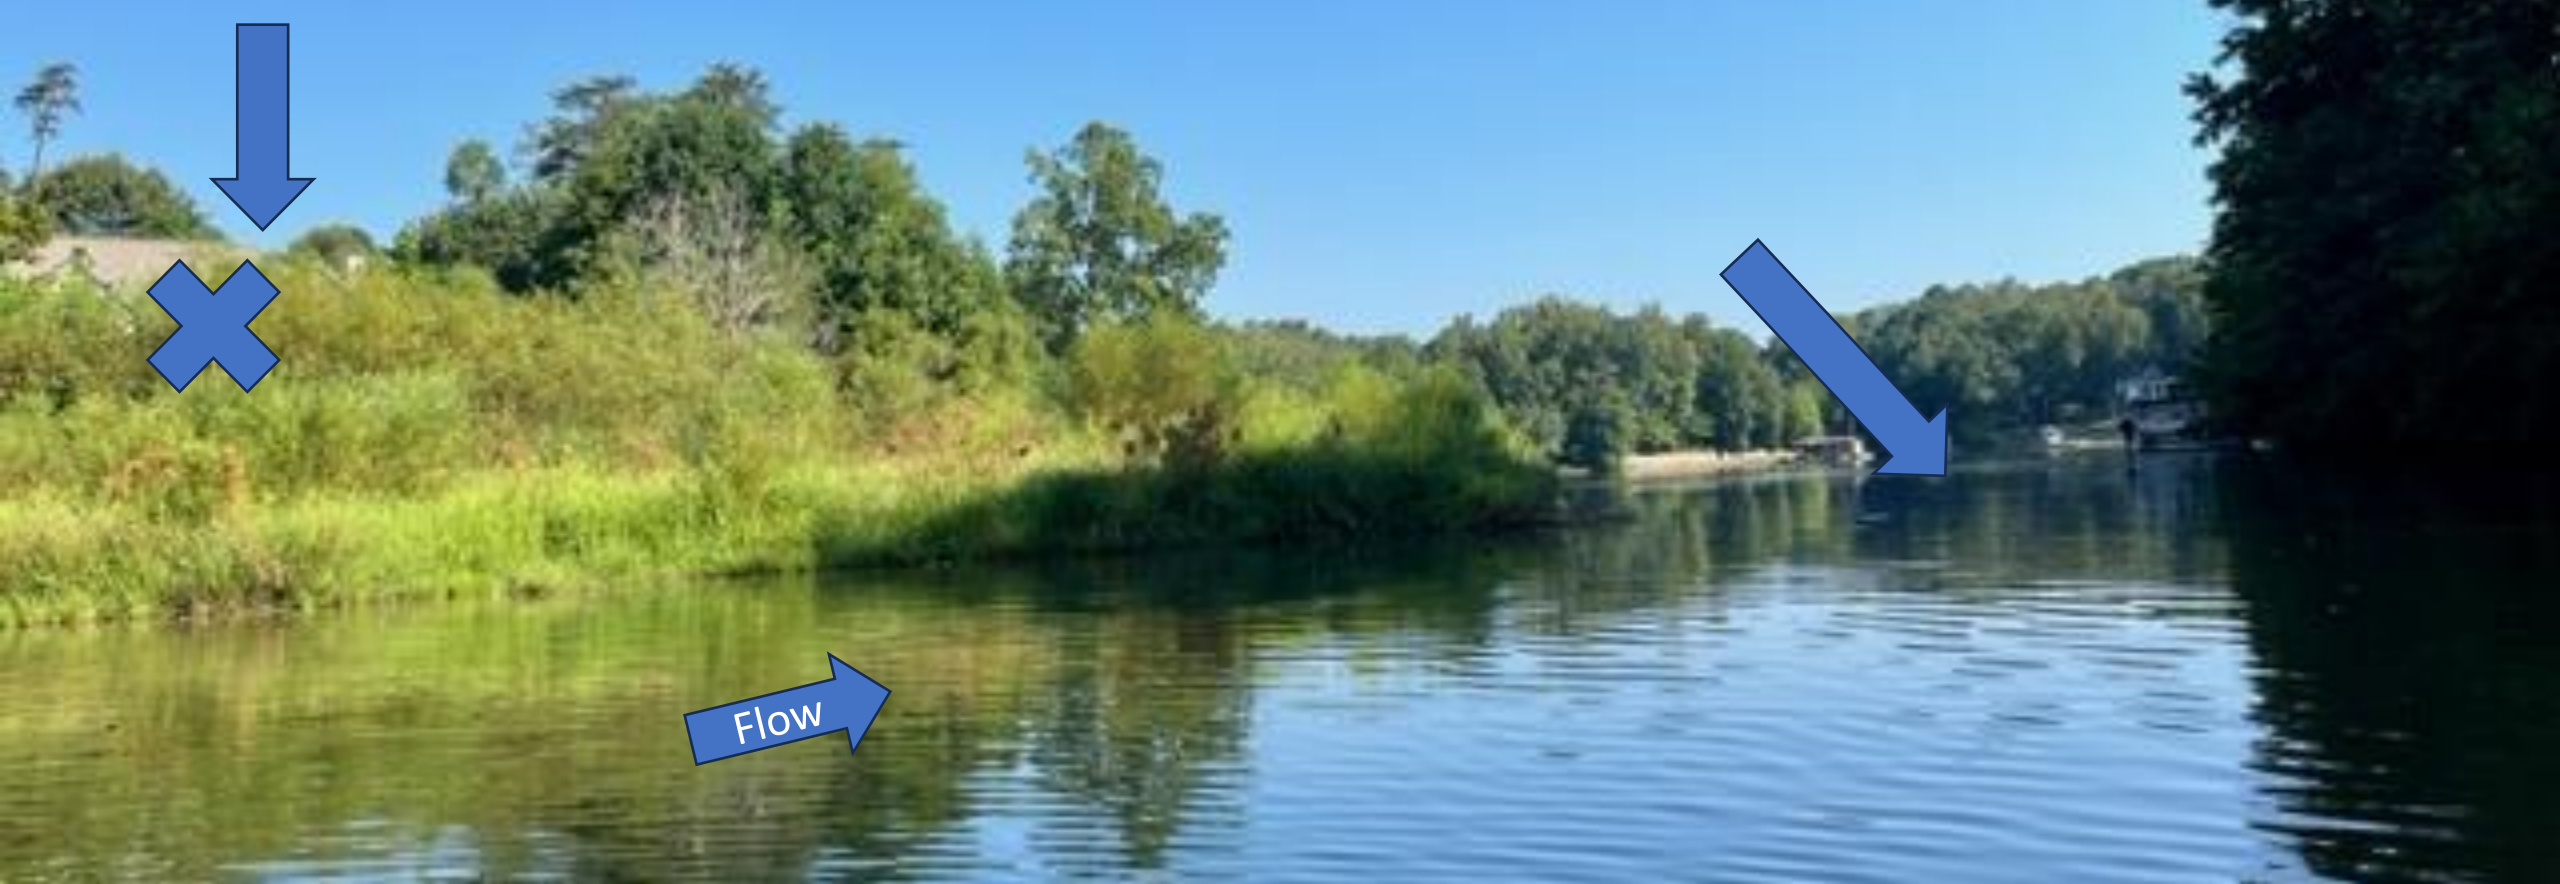
A closer shot from a dock in the channel. Below the left arrow is the home and dock marked as X in the previous slide. This Inlet home was waterfront. The angle is looking toward the “bowl” (arrow to the right). This house has a completely obscured large dock due to a huge buildup of stored sediment. Due to this sediment, the channel leading you see is now only a third as wide as the original lake shows. Profile 2 on the measurement goes across that channel.

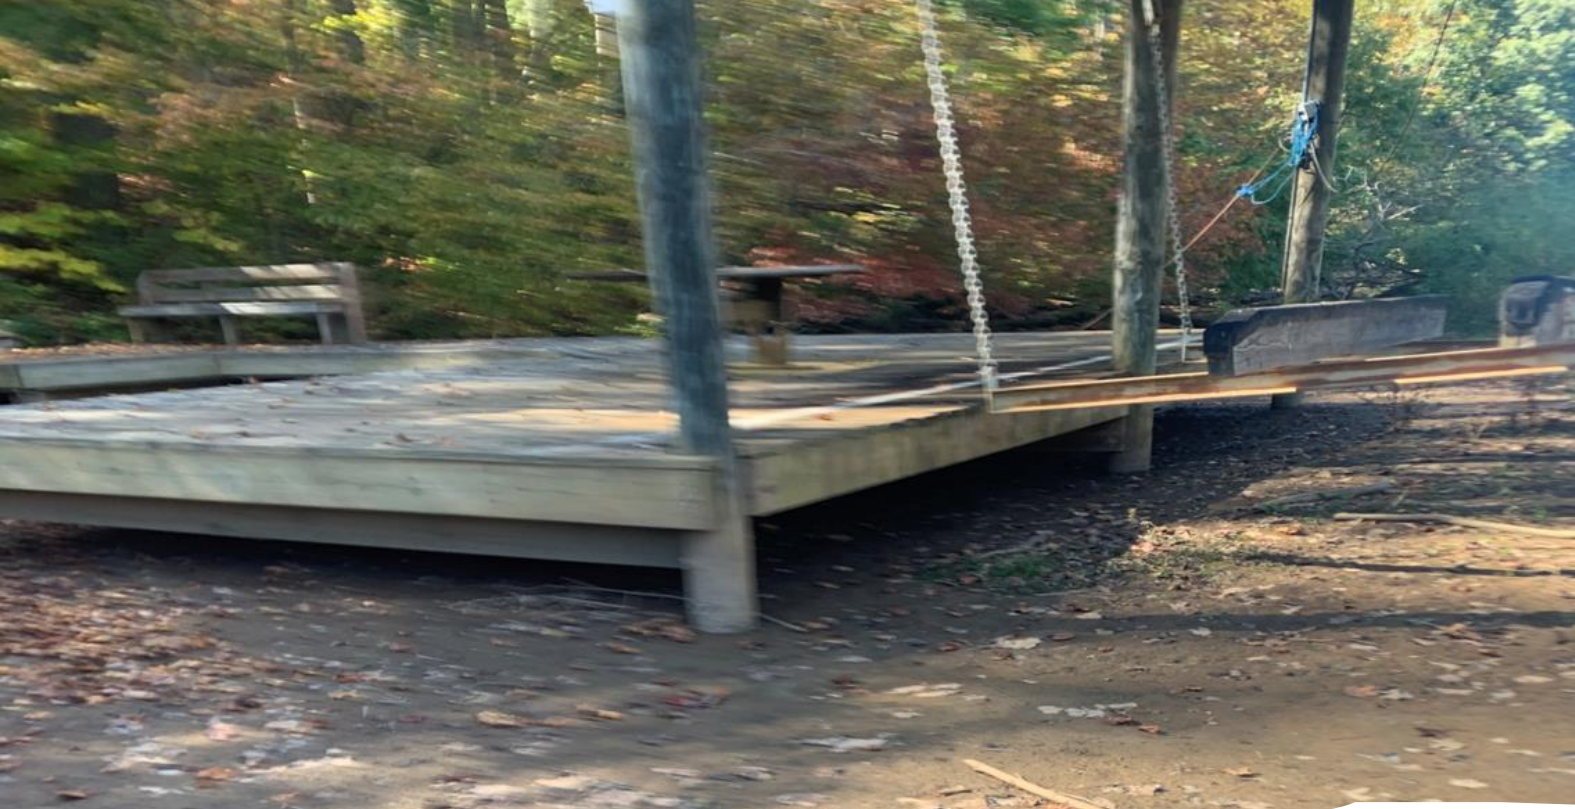
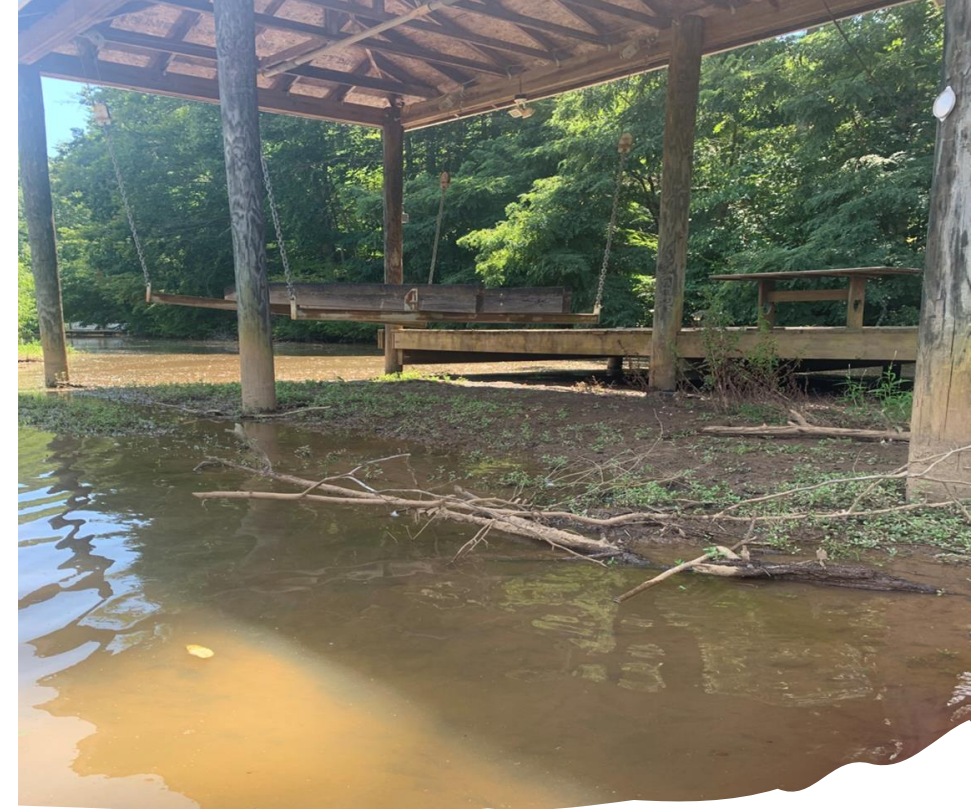
**That dock now looks like this. Completely unusable. This is the Tucker property. 7 years later.**

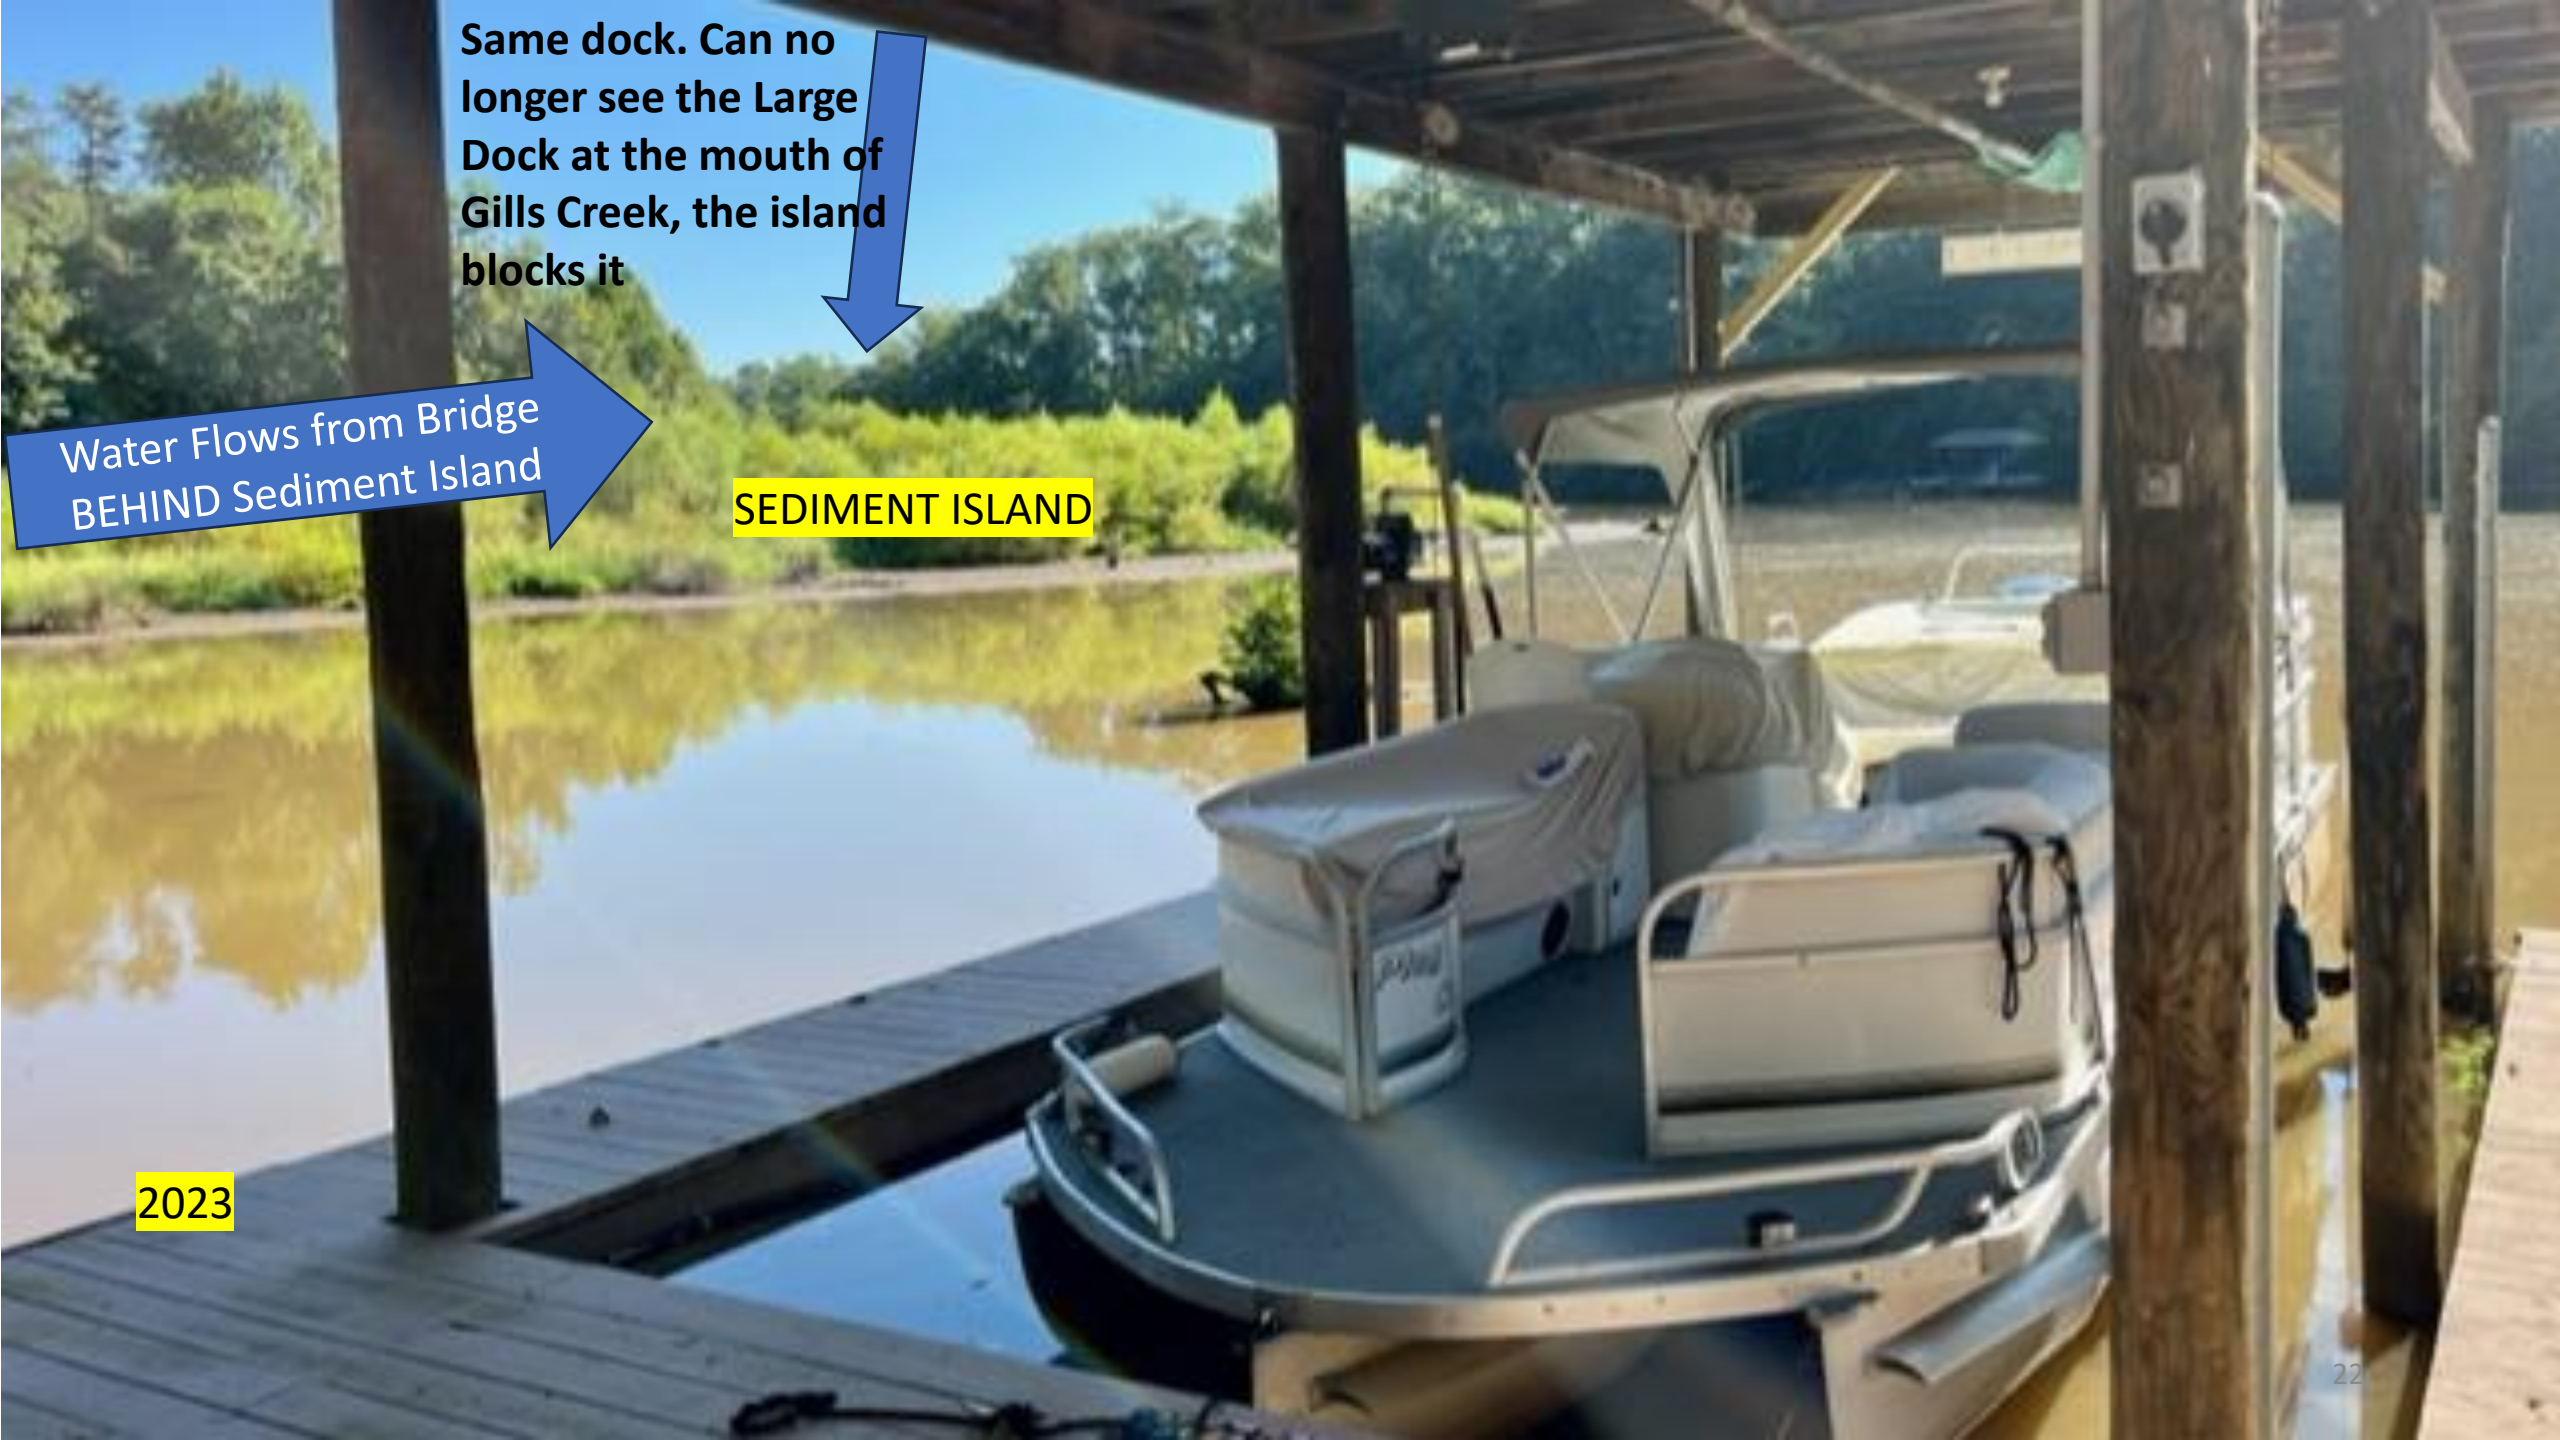
Same dock. Can no longer see the Large Dock at the mouth of Gills Creek, the island blocks it

Water Flows from Bridge BEHIND Sediment Island

**SEDIMENT ISLAND**

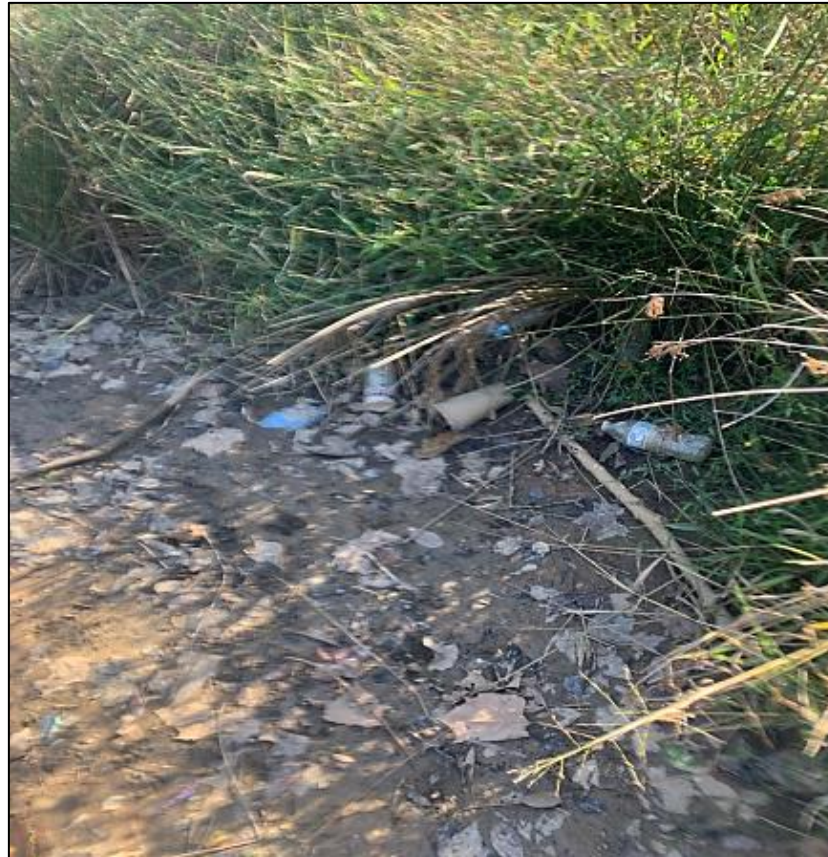
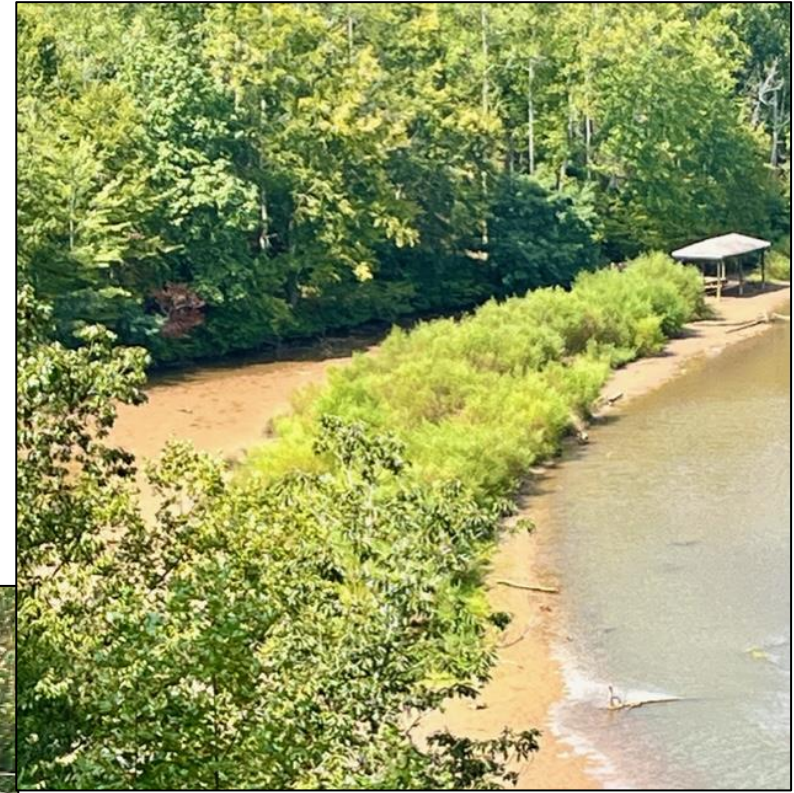
Above is a view of the north end of Gills Creek Sediment Island as it connects to the Tucker's dock, shutting off lake access from their dock.

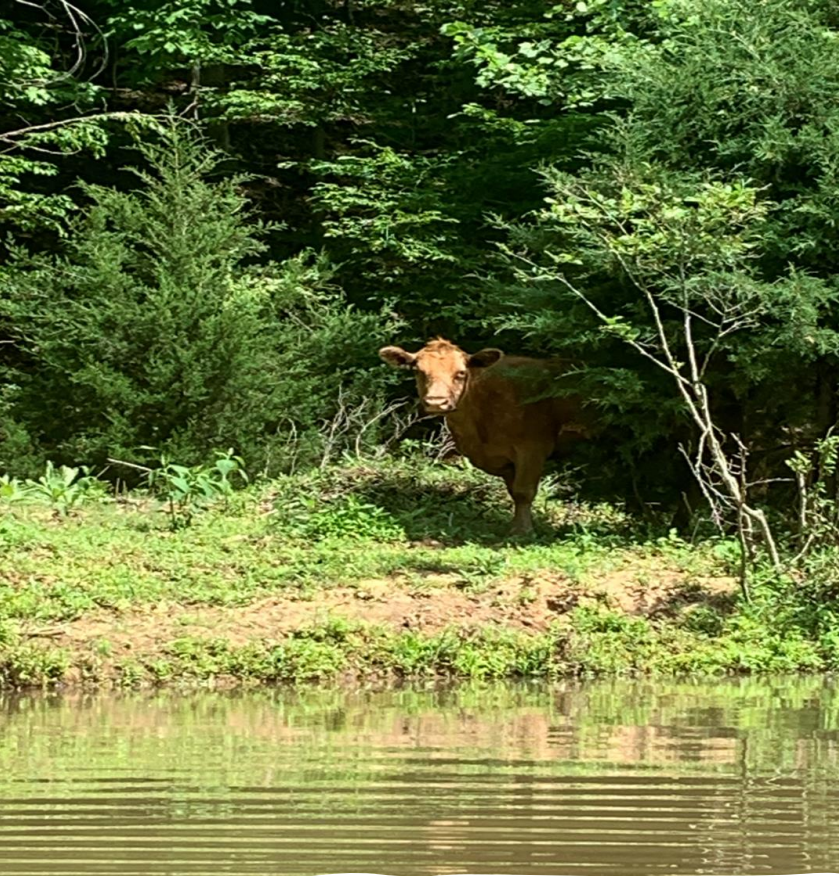
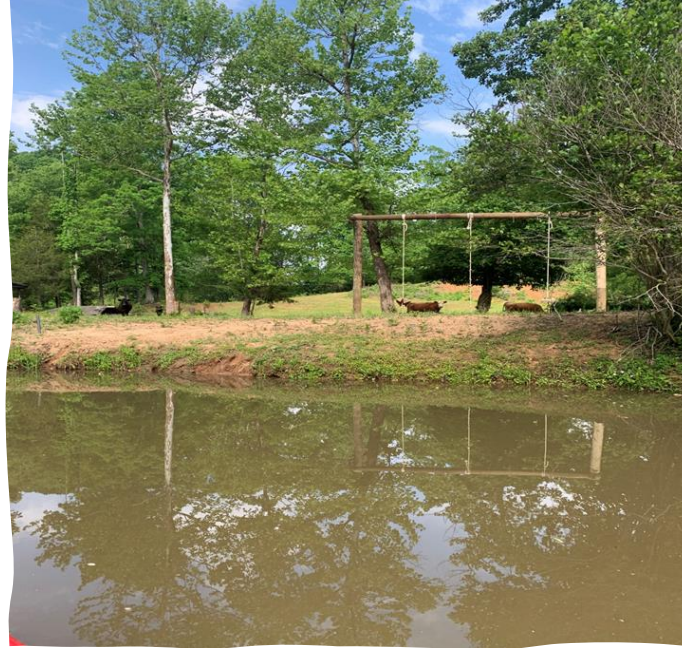
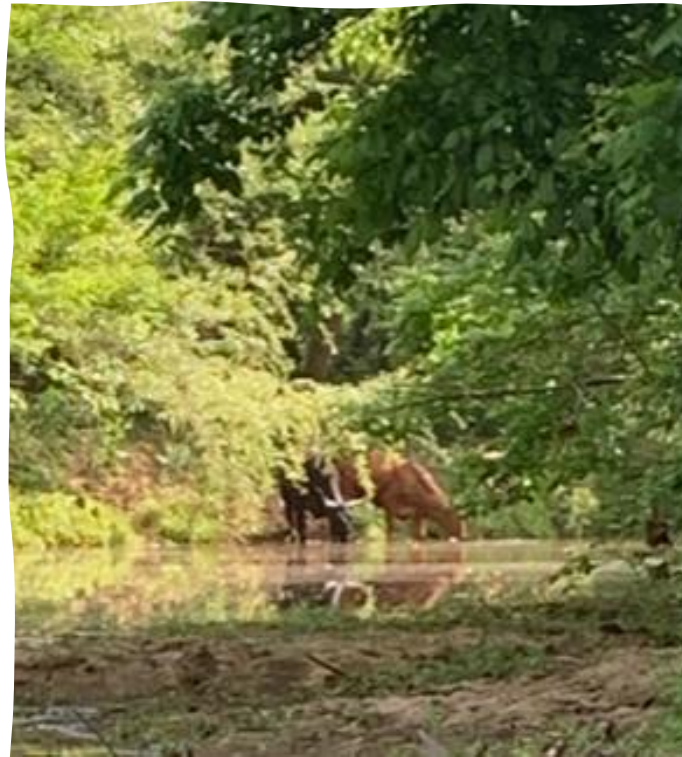
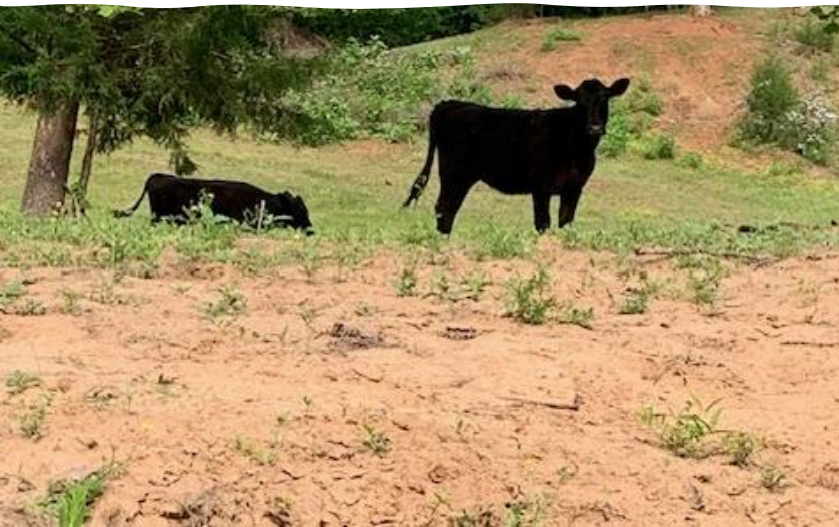
- Little or no regulation upstream to keep cattle out of the creek
- Construction and clearing of shoreline upstream
- No collection of debris that washed down after large storms, getting caught in the curve and collecting sediment flowing down. *Debris used to be collected in the upper Gills Creek area.*
- No mitigation of sediment before it creates a problem for navigation
- No plan in place to ensure AEP permitted docks will have flowage for use in the future
- No response to citizen's request for help—AEP told me that they don't own these islands, the original landowner does!
