**SML**  
**Sedimentation Monitoring Plan**  
**Project 2210-197**

Input on 2021 Draft Report  
SML Citizen Action Group  
September 30, 2023, updated 10/25/23

# Gills Creek Monitoring Site Citizen Input

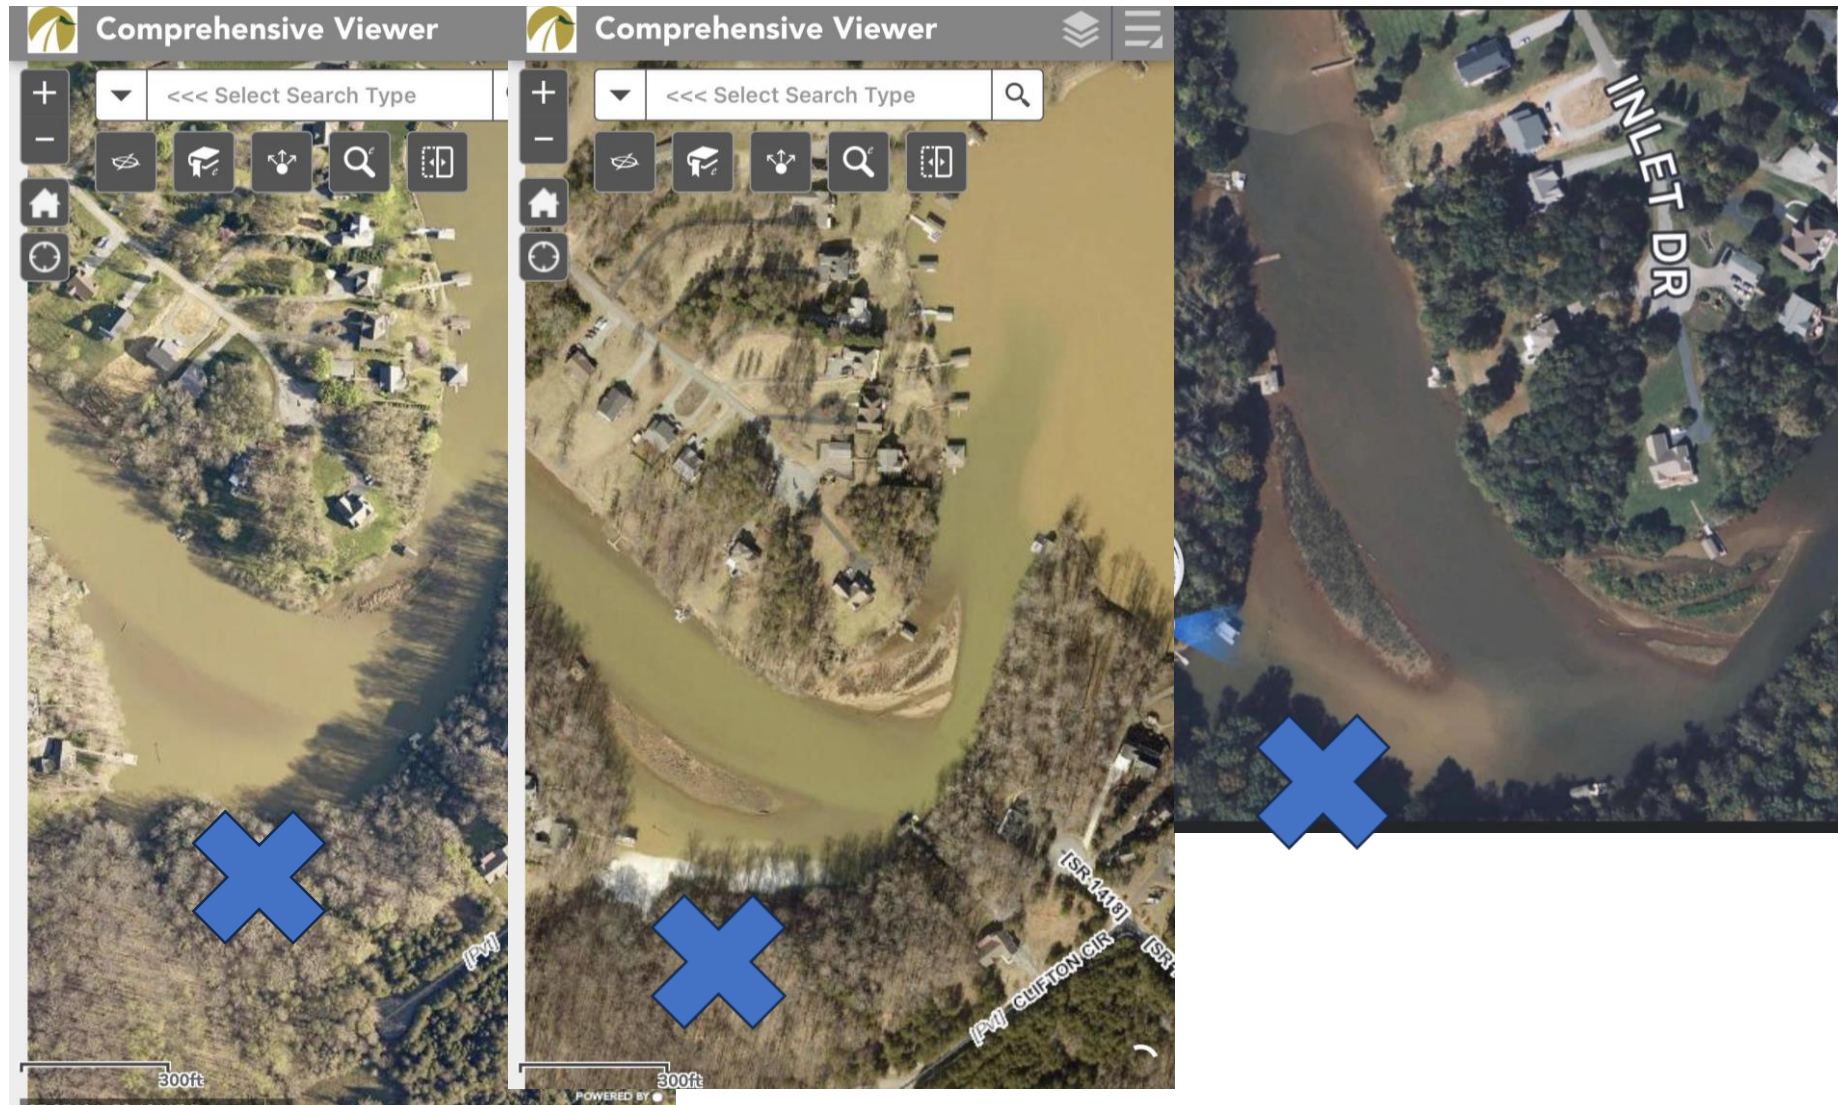
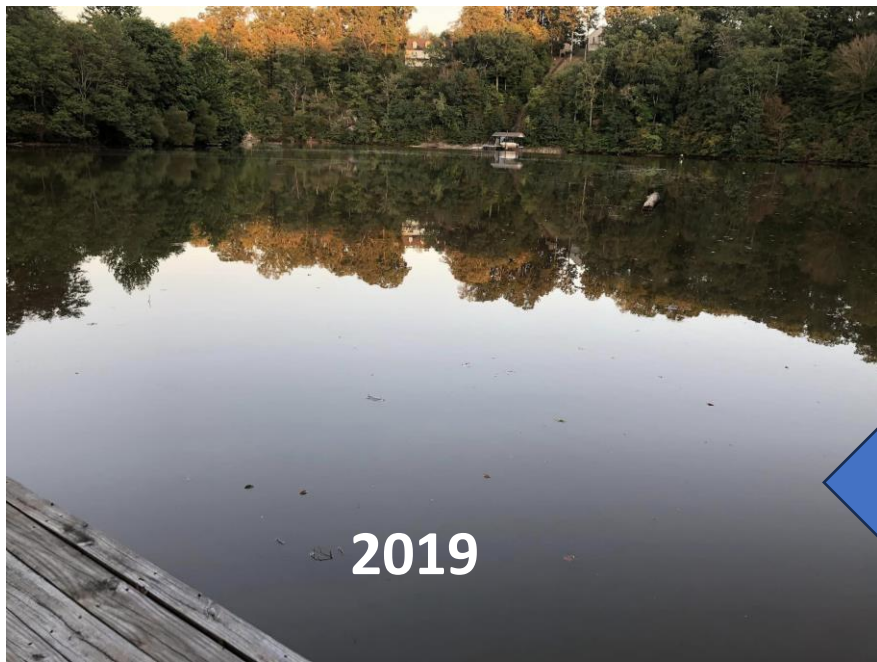
I am a concerned citizen Randy Frye, owner of lot #8, Forest shores subdivision in Wirtz VA. First picture is when we purchased property in 2020. Other pictures are the island that keeps growing and damming our property in. Please help with some type of dredging as this sedimentation buildup impacts marine life, property values etc. Randy Frye

(X indicates property location approximately)

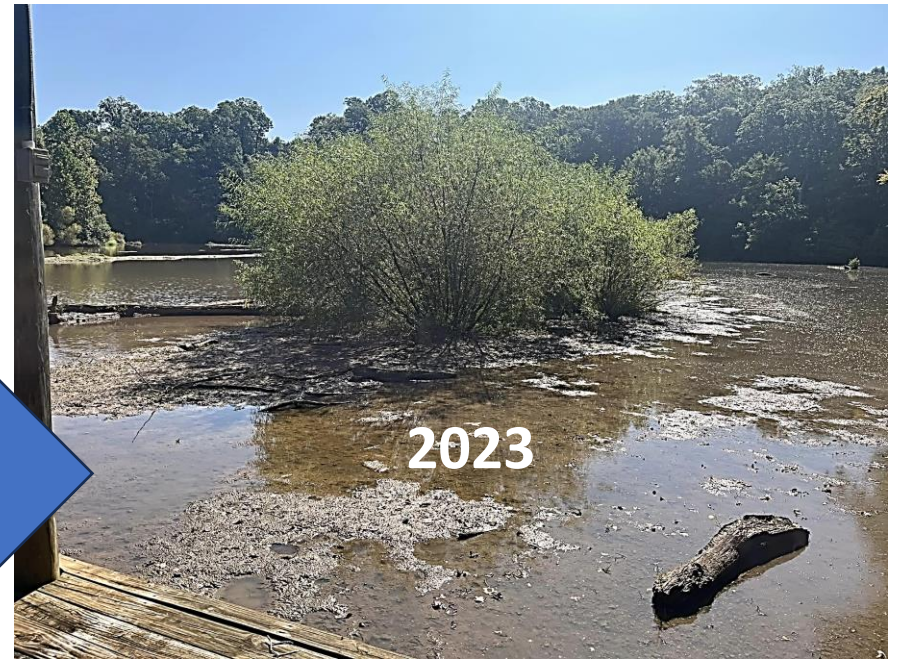
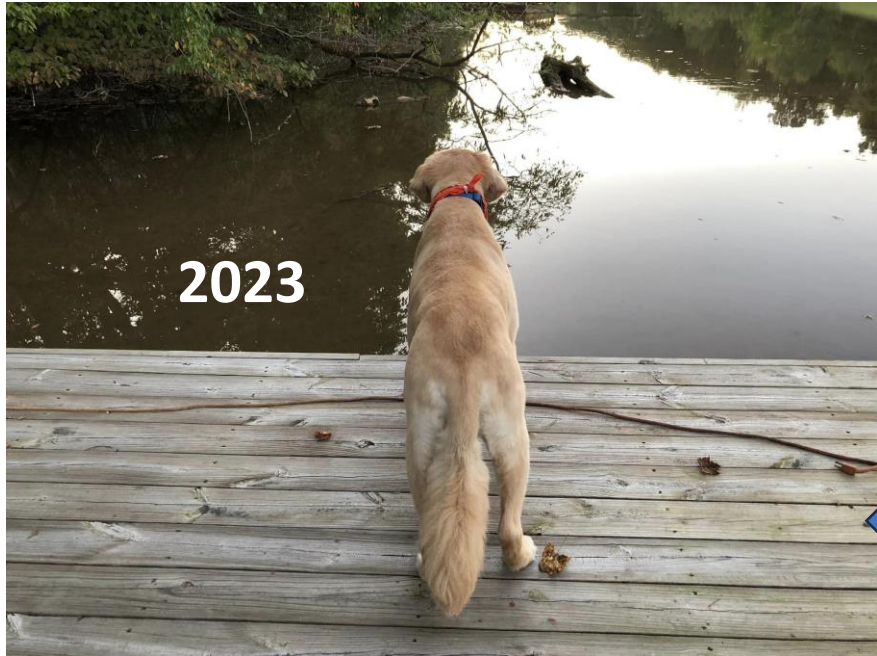
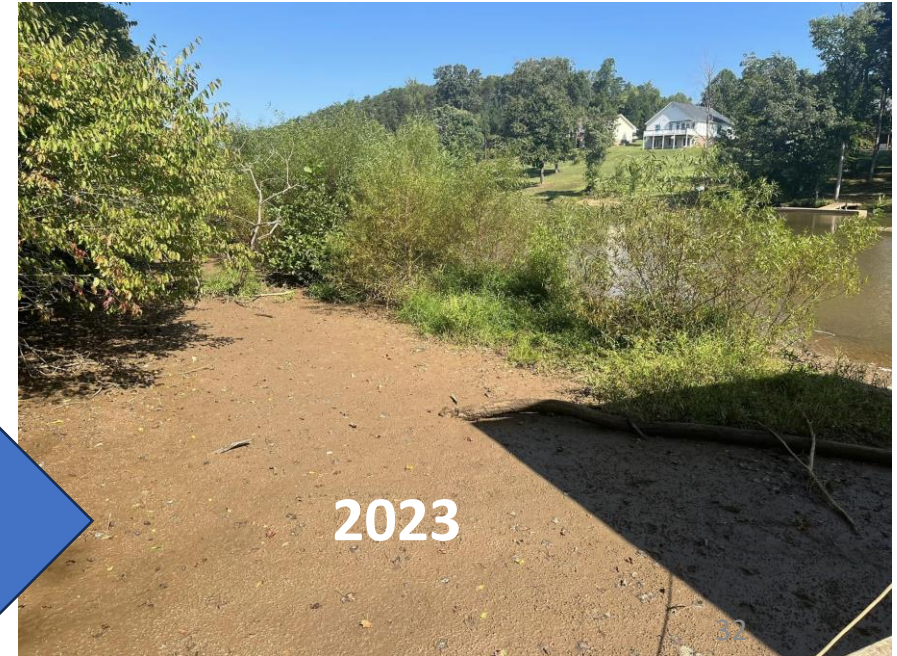
Same photo shot at the lake from the dock 4 years later

Full sediment on one side of dock and debris other

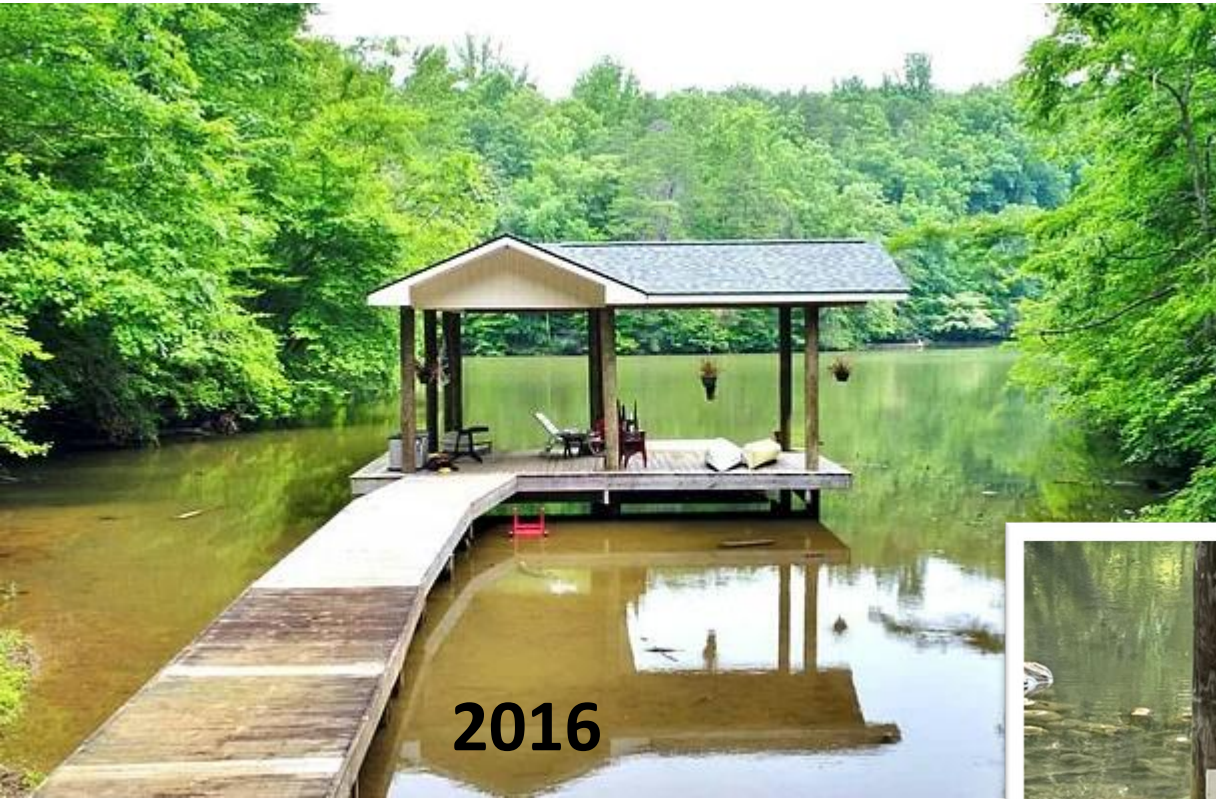
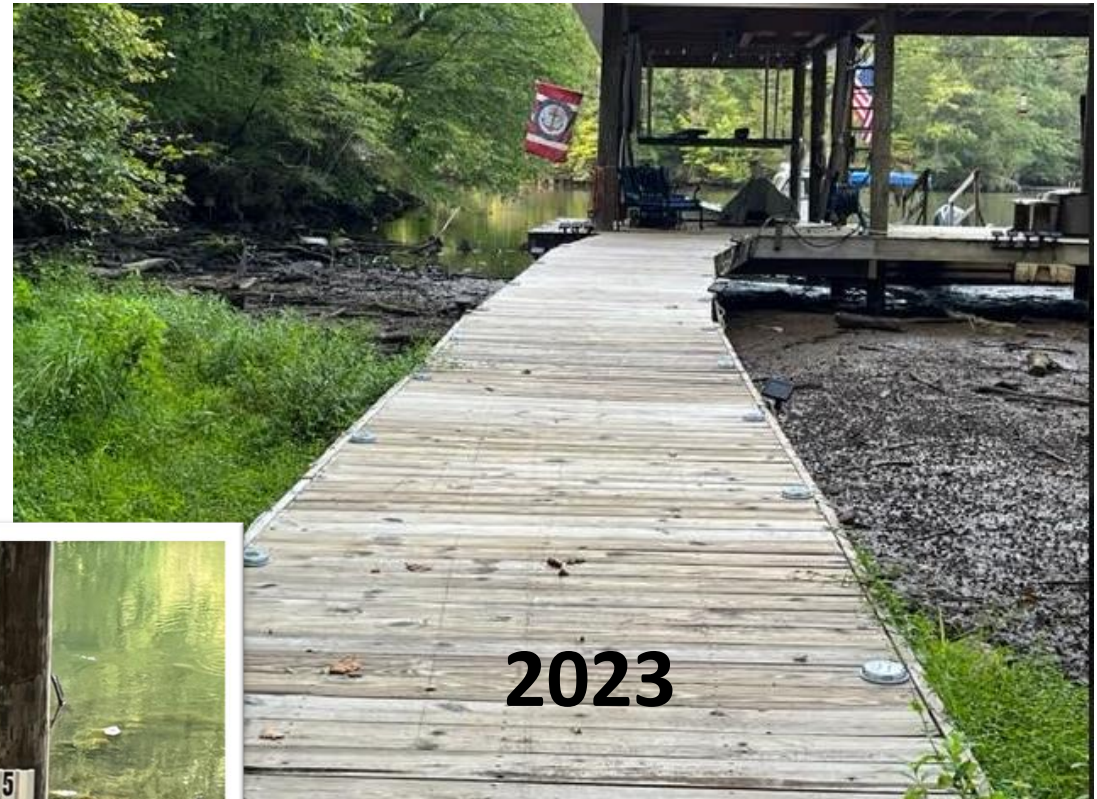
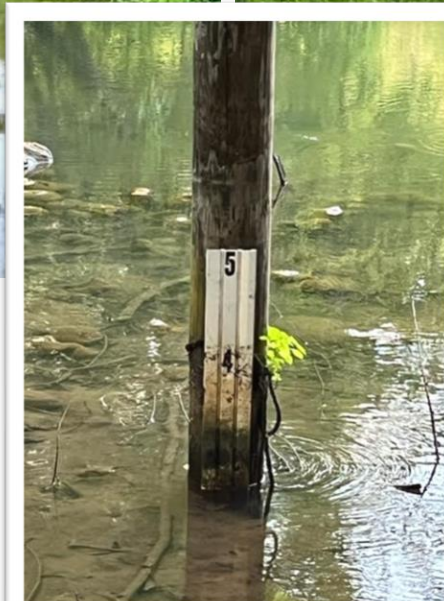
You can see the 5-foot water depth marker--3 feet of sediment in just over 4 years

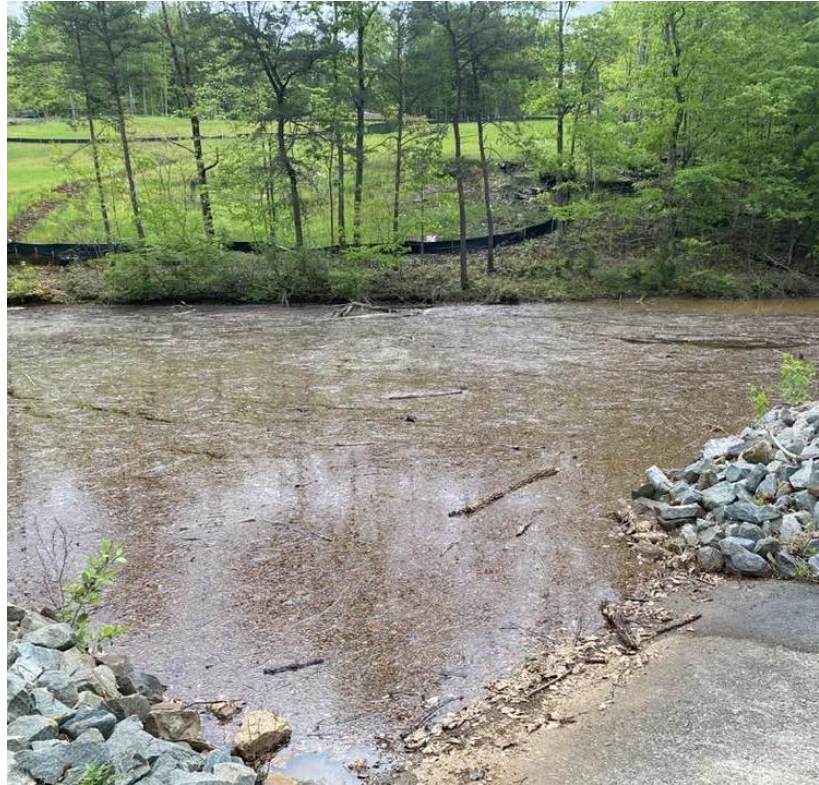
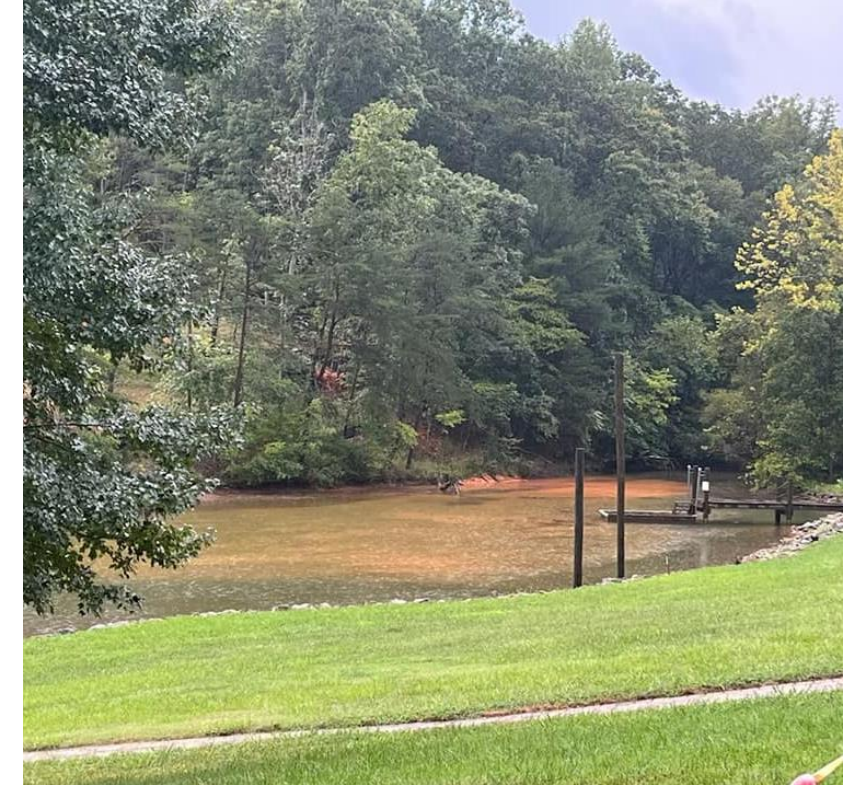
This is at the end of Woodland Cove at R25 after a rain

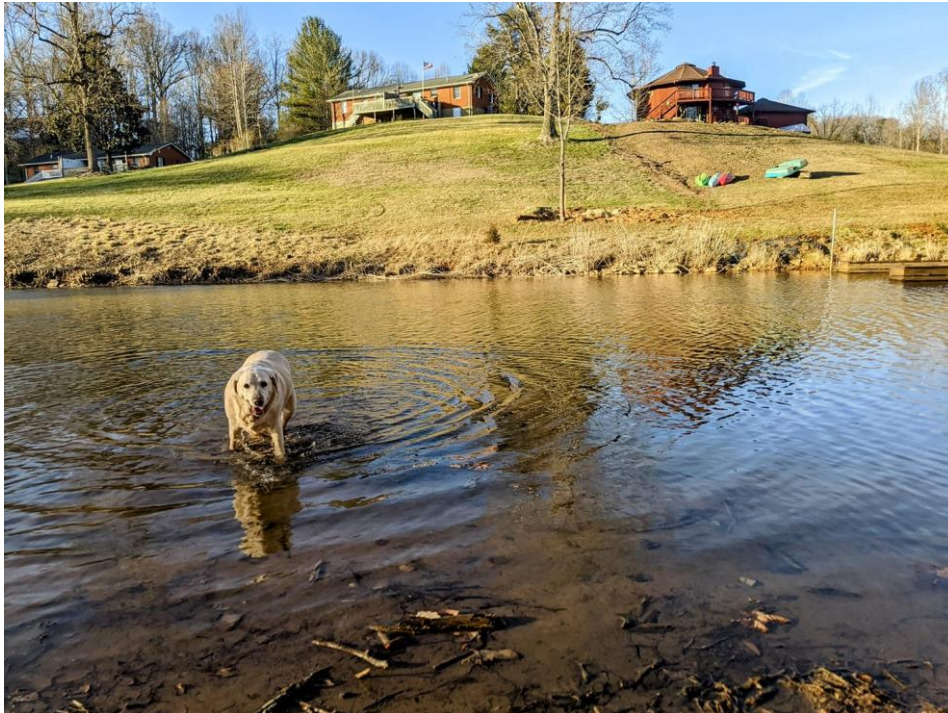
Used to be able to park a boat at our dock there, just on the right.... now we have a shoal that we can walk on that has split our cove **and we can barely get the kayaks out now** ...this pic, I'm standing on the shoal...

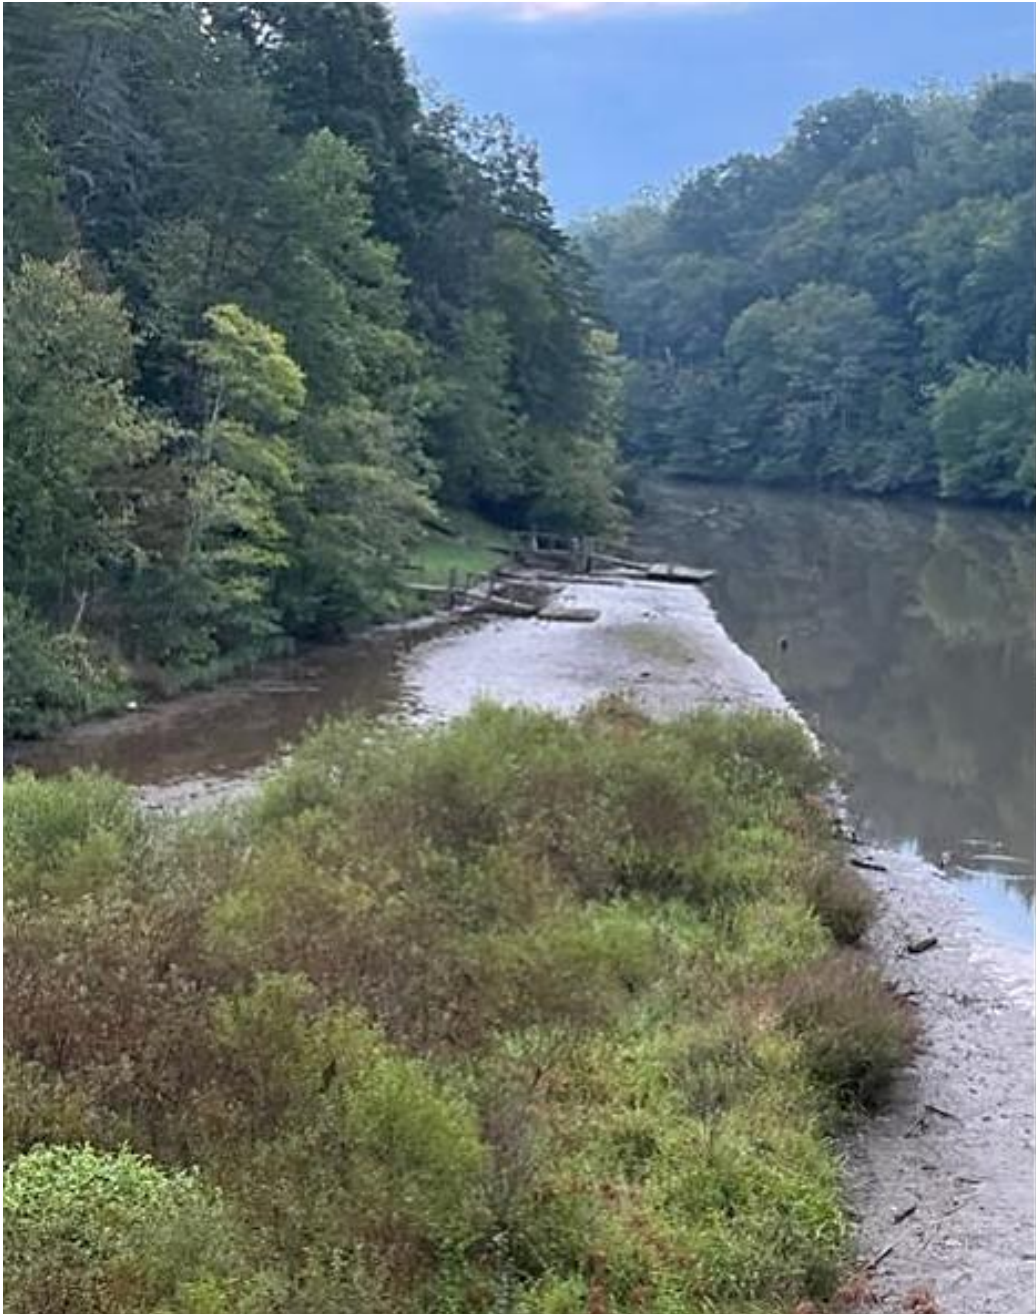
Lynville Creek is no longer navigable to the bridge on Hardy Road, unless in a small craft like a kayak.

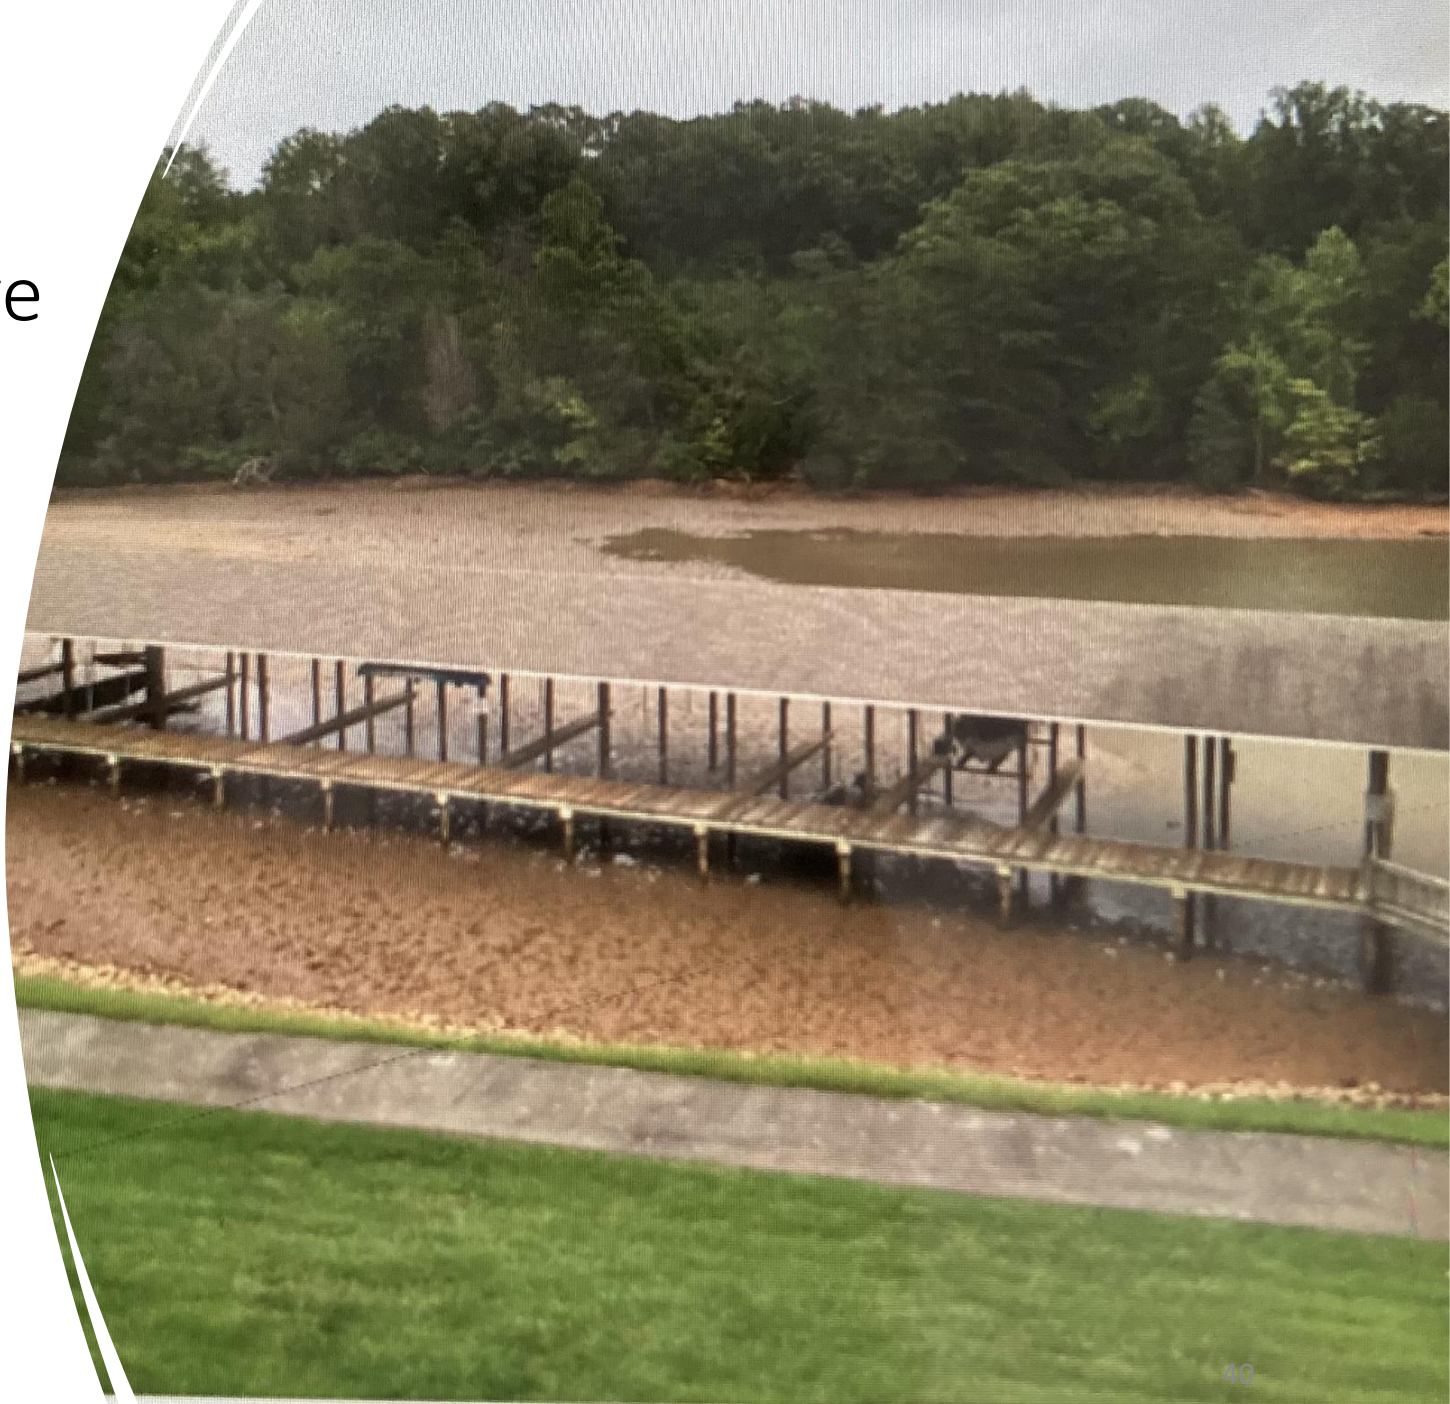
Our property is waterfront on Craddock Creek, up from the Mariners Village boathouses. This portion of the cove is silting rapidly, due to excessive storm water runoff through large culverts from undeveloped land and the opposite shoreline with inadequate erosion control. The landowners and AEP do nothing to address this issue. A mud island has formed that becomes visible during low water conditions, and there is a set of boat slips that are not fully usable due to sediment in the slips and the channel. This area is not addressed in the Monitoring Report.

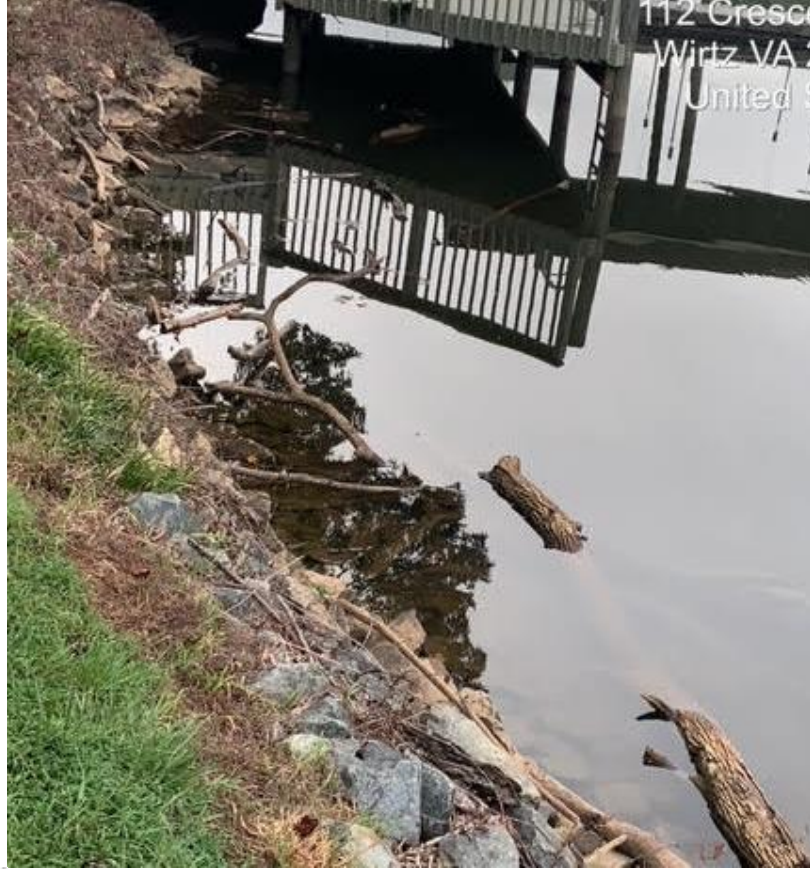
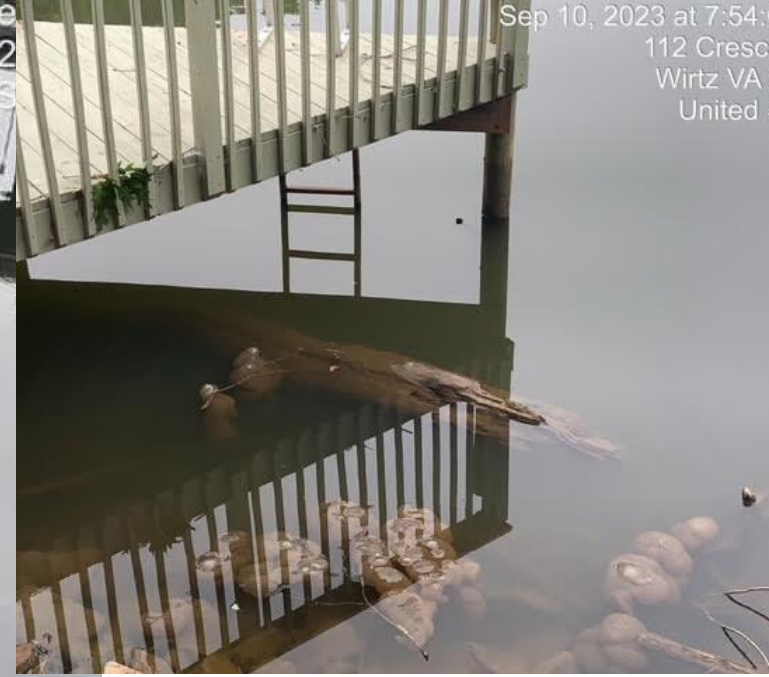
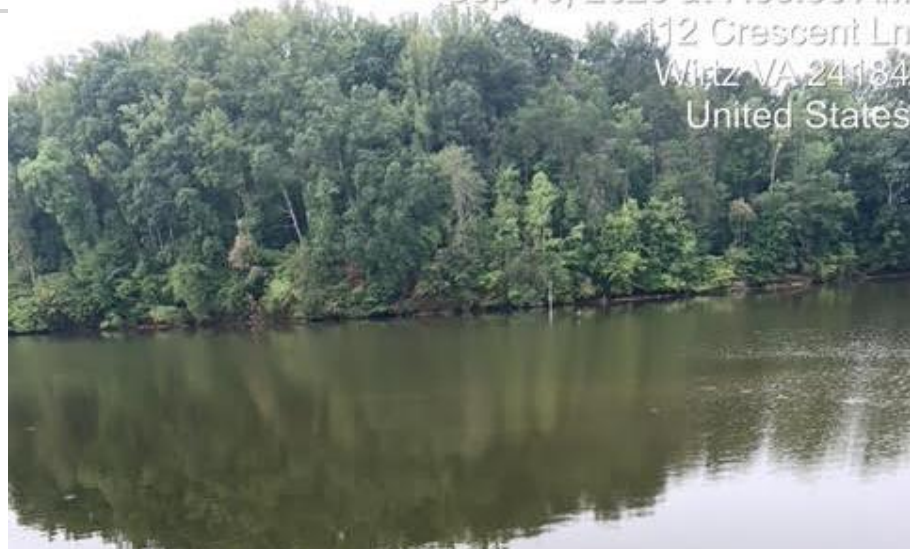
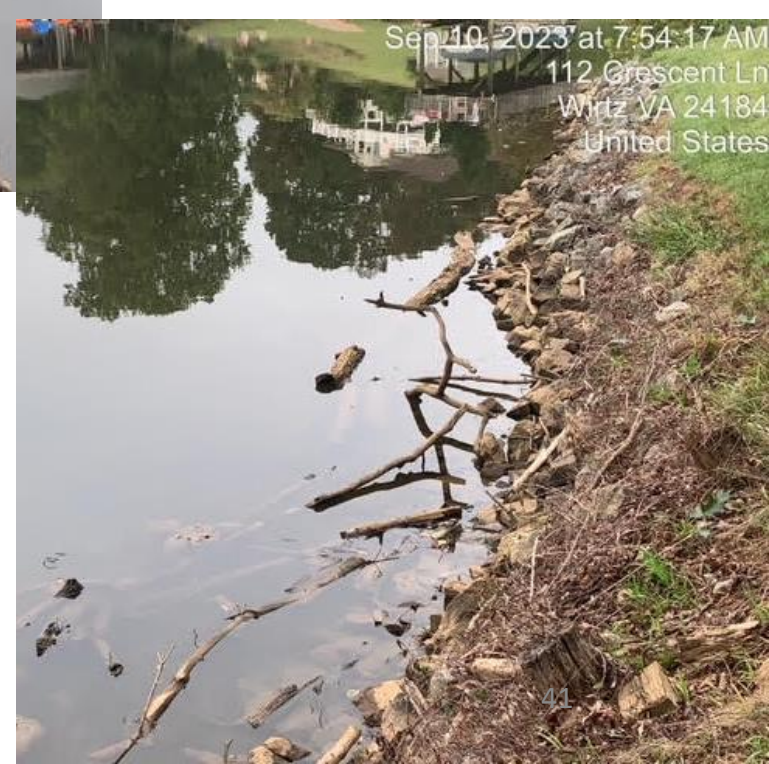
Unfortunately, no one made us aware of the issues in our channel. We actually have OK depth off our dock but if you go about 30 feet out it becomes 5 feet or less. Tree limbs get stuck in the sediment and cause issues for boaters.

We purchased in June 2023, so I really don't know much history, but I plan on trying to push AEP on removing large limbs along my shoreline and managing the channel at least as far as channel marker B49.

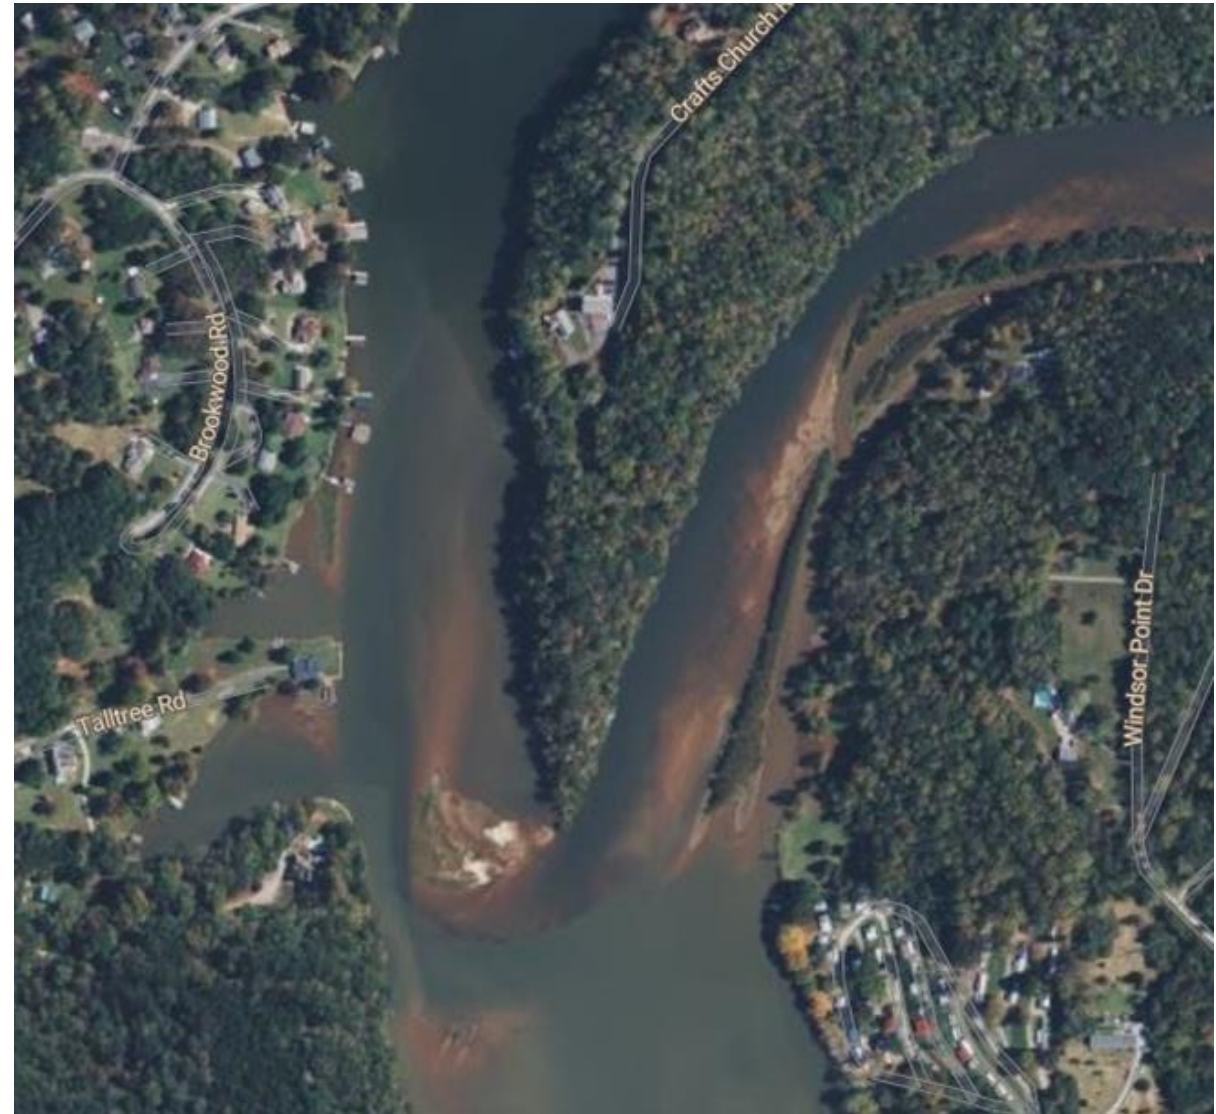
- We live on the Blackwater, and we are not yet affected. We have owned our property over 24 years and the depth of water at the end of our boathouse has gone from 16' to about 12'. However deeper in our cove where we once skied has become islands and unnavigable even for a jet ski. There are several homes with unusable boathouses. We are in Union Hall off Long Horne and Major Holland Roads. By water we are left of B41.
- And if you continue past B41 it also was plenty deep and skiable all the way to Ponderosa Campground and the same has happened, it's unnavigable with islands of soil.
- My husband and I see this as it should be dredged back to lake levels from when the lake was built. We believe as a man-made lake, these are not wetlands. They would never be natural wetlands if the lake was not built.

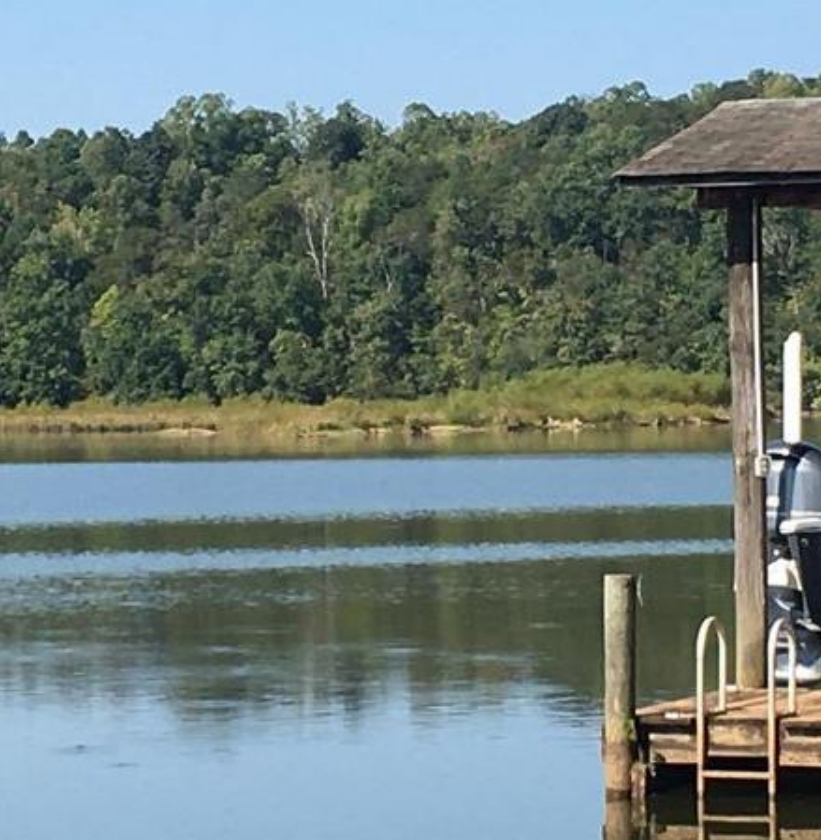
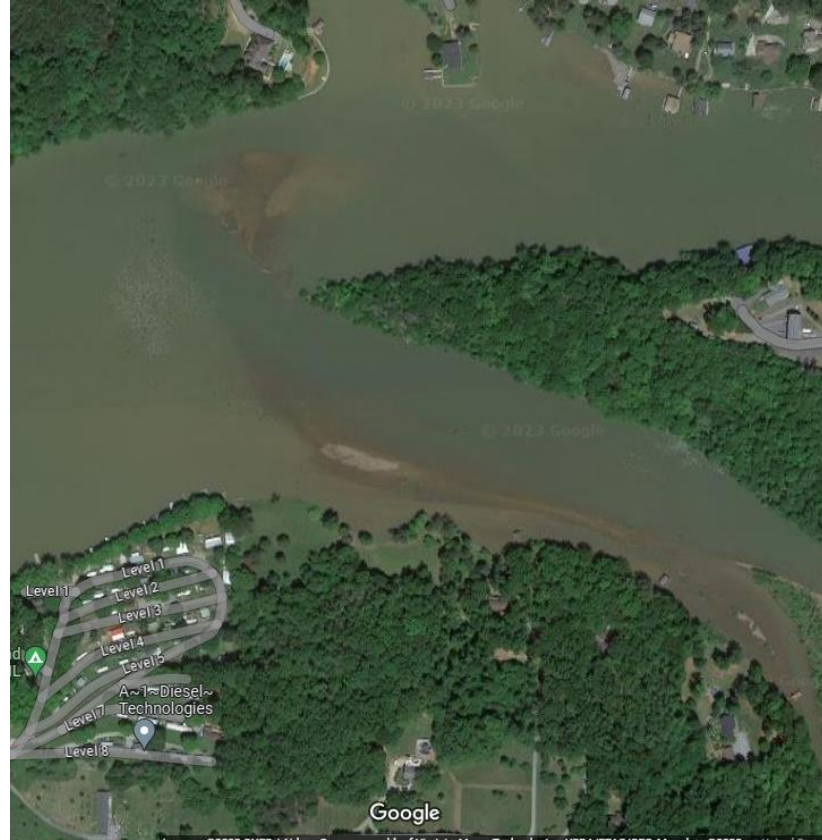
This is beyond channel marker B49 at Horseshoe Bend area of the Blackwater. There is an island of sediment with bushes and grass growing on it. The left-hand side is only inches deep and you can no longer navigate a boat in that area. The right side still has a path that boats can navigate through to get to the campground area. I've heard tales from neighbors that have resided here for years that you could ski through this area to the Blackwater Bridge.

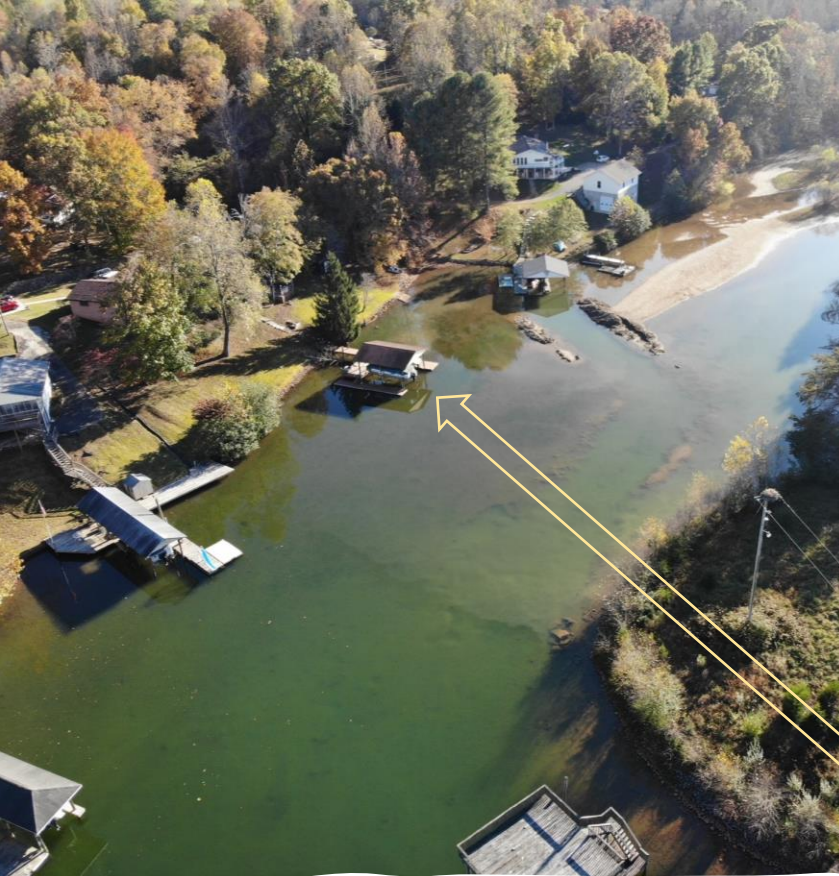
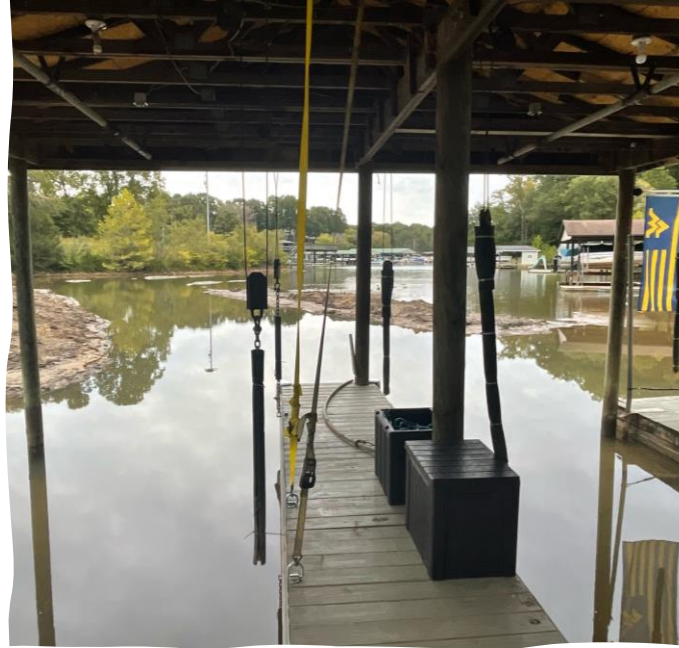
Photos taken at Windsor Point Drive, the Horseshoe Bend portion of SML. Our property used to be lakefront and adjoins to the shared community area which includes a covered boat house with 4 slips, a cement boat ramp, a cement docking wall and a pier. Photos show the sad state of affairs....all silted in and unusable even for a kayak. We can't even access the horseshoe bend portion of the river at all. If this was dredged it would be amazing. We could possibly do a retaining wall with a community garden to retain the silt removed if disposing of it is an issue.
