NONPOINT SOURCE SUCCESS STORY

Agricultural Best Management Practices Improve Aquatic Life in the Blackwater River

EPA 841-F-16-001B
January 2016

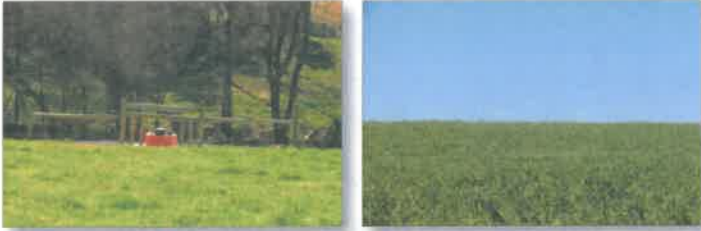
Figure 2. BMPs installed in the Blackwater River watershed include alternative livestock watering systems (left), and small grain cover crops (right). Photos courtesy of Blue Ridge Soil and Water Conservation District.

A number of agricultural BMPs were installed from 2002 to 2012 to reduce sediment loads in the subwatershed area containing the impaired segments. These BMPs include 29,323 linear feet (5.6 miles) of livestock exclusion fencing, 258 acres of small grain cover crop, 37 acres of harvestable cover crop and 38 acres of legume cover crop (Figure 2). Also, various BMPs were installed in the Upper Blackwater River watershed, which affected downstream sediment loads and helped improve water quality. These BMPs include 42,660 linear feet (8.2 miles) of livestock exclusion fencing, 2,211 acres of small grain cover crop, 344 acres of harvestable cover crop and 96 acres of legume cover crop. Also, four animal waste storage facilities were installed in the watersheds.
